**RE: Tree inspection- 1 x *Celtis sinensis*- Chinese Hackberry.**

This letter has been provided to discuss the recently completed inspection of a semi-mature *Celtis sinensis*- Chinese Hackberry, located within the rear of 27-29 George Street, on the Southern boundary of the subject site.

Our brief was to inspect the tree and provide details regarding the tree protection zone (TPZ) and structural root zone (SRZ) and also quantify the level of impact that would likely result from pruning the tree back to the property boundary to enable construction of a new building.

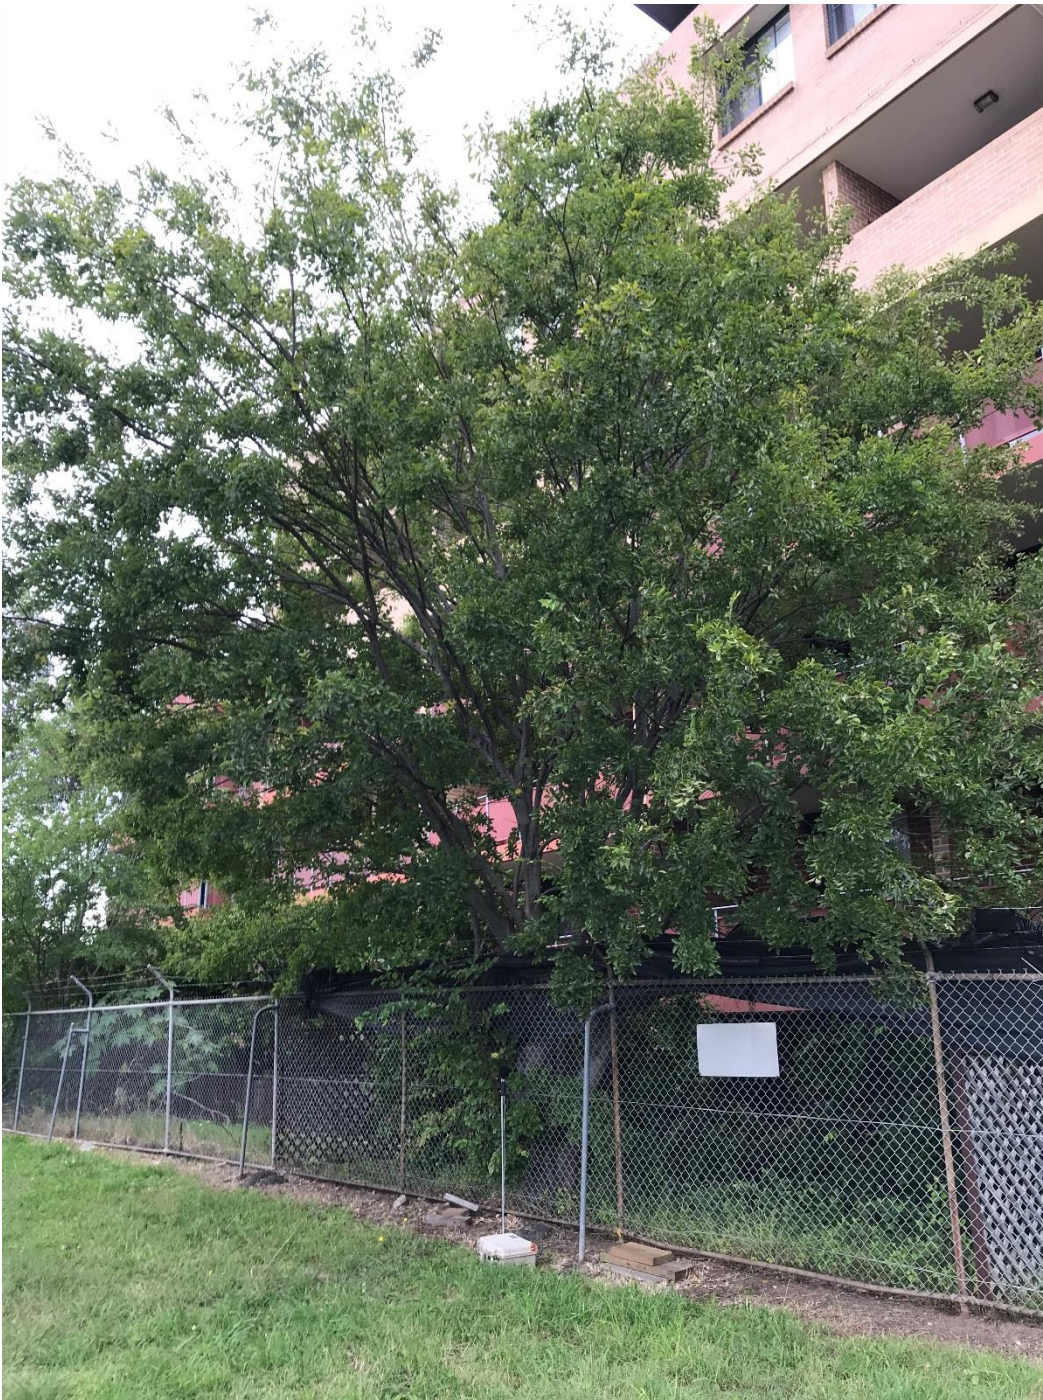
**Figure 2: The subject tree**

The subject tree was positively identified as a *Celtis sinensis*- Chinese Hackberry, which is a common self-sewn weed species throughout the greater Sydney region. The tree is semi-mature and has the potential to grow to at least double its current dimensions, making it inappropriate for long-term retention in its location directly adjacent to the boundary fence.

The tree currently provides some level of amenity through screening between the properties, however, the tree is deciduous, so this screening is probably far more beneficial through the summer months. The tree was displaying fair health and vigour with evidence of sap sucking insect infestation and sooty mould on some of the lower foliage. The tree had poor structure with multiple co-dominant stems originating from ground level. The tree was approximately eight (8) metres in height, with a canopy spread of approximately ten (10) metres North-South and ten (10) metres East-West.

The tree was on the neighbouring property so the trunk dimensions have been estimated. The tree had a diameter at breast height (DBH) of approximately 410mm once all stems had been collectively calculated in accordance with AS4970-2009- The Protection of Trees on Development Sites. This results in a notional TPZ of 4.9m radius measured from the centre of the tree. The tree had a Diameter above buttress (DAB) of approximately 480mm, resulting in a structural root zone (SRZ) of 2.4m measured from the centre of the tree. The centre of the tree is approximately 500mm beyond the property boundary so the

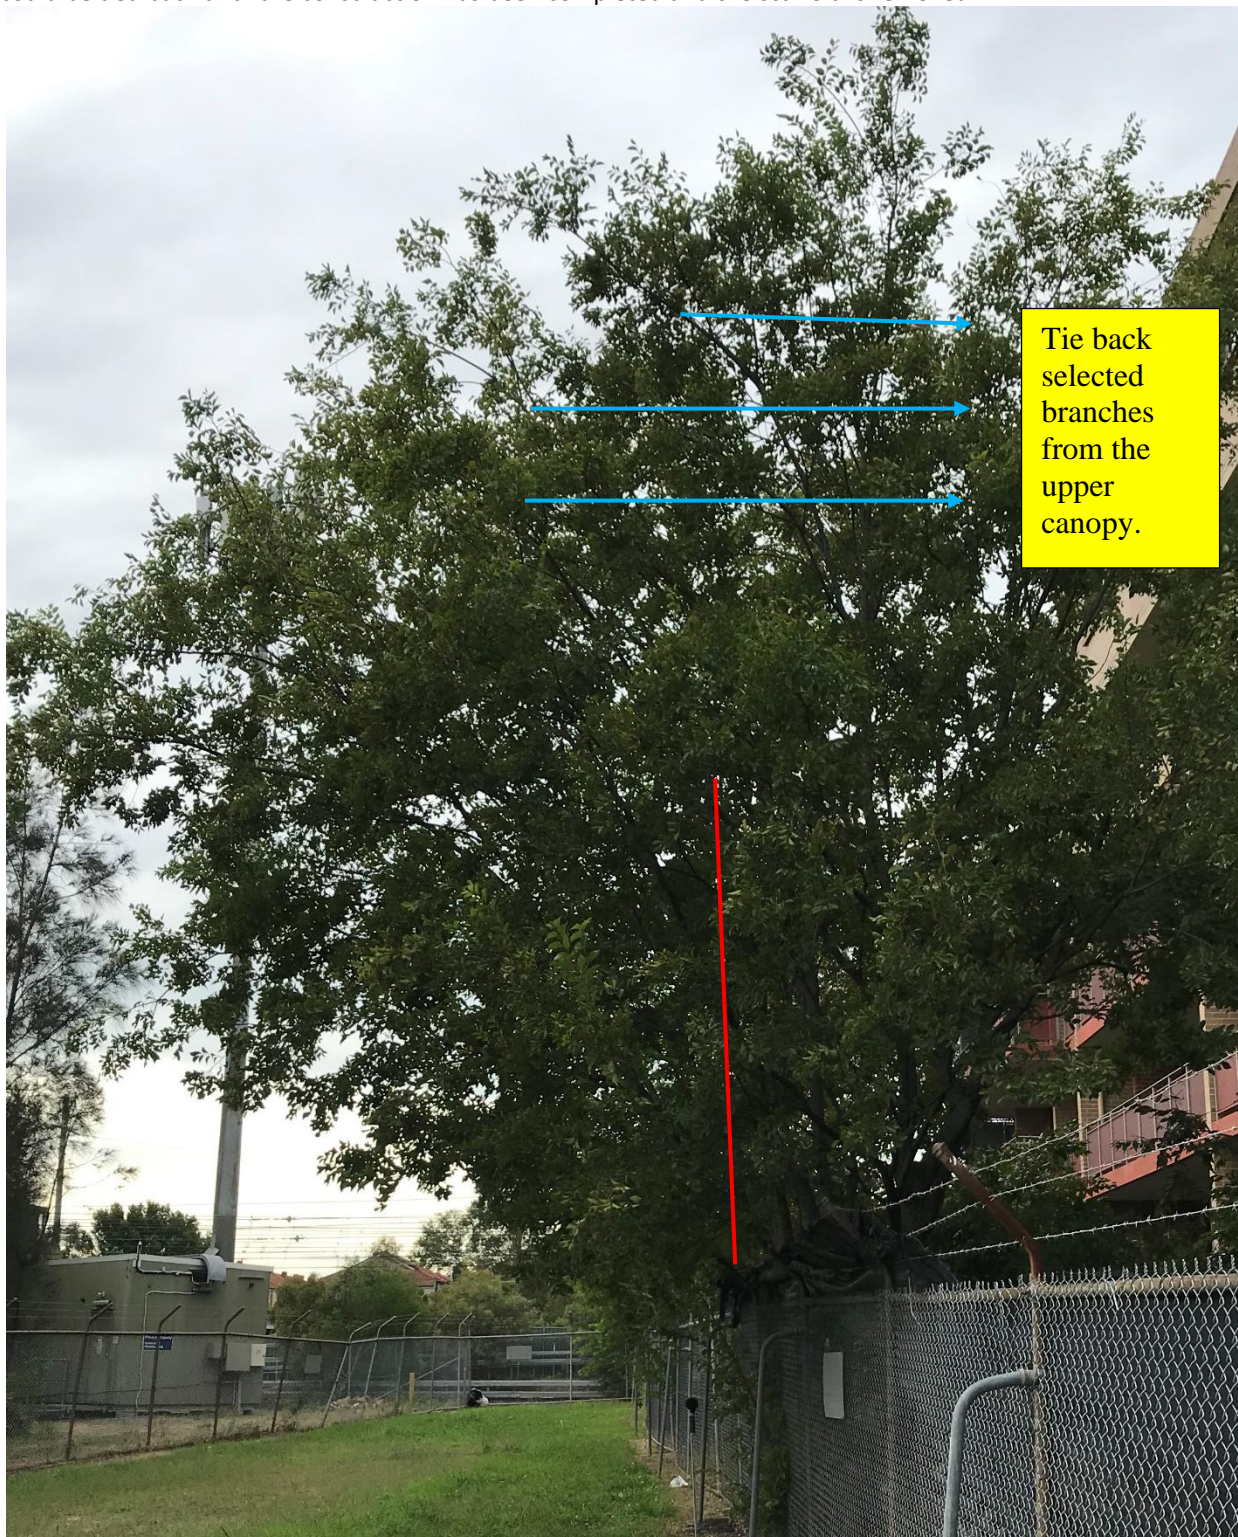
I have not been fully briefed on the requirements for the proposed structure, however there will likely be the need for scaffold to be installed to complete exterior works, for this to be possible, the intent is to prune most of the branches overhanging the fence line. This is unlikely to impose significant impact upon the tree, however, it may result in an unappealing appearance. To counter this it appears possible that the majority of the lower branches could be pruned whilst some of the upper branches could be tied back until the construction has been completed and the scaffold is removed.

Figure 3: The red line represents branches which will require pruning. The blue arrows represent branches which may need to be tied back to enable the scaffold to be installed.

- All pruning and tying back of branches must be completed by an AQF level 3 practicing Arborist and overseen by an AQF level 5 Consulting Arborist.
- The centre of the tree is approximately 500mm behind the property boundary.
