Concord Zone Substation

Geotechnical Investigation Report

Zinfra Pty Ltd

11 January 2020

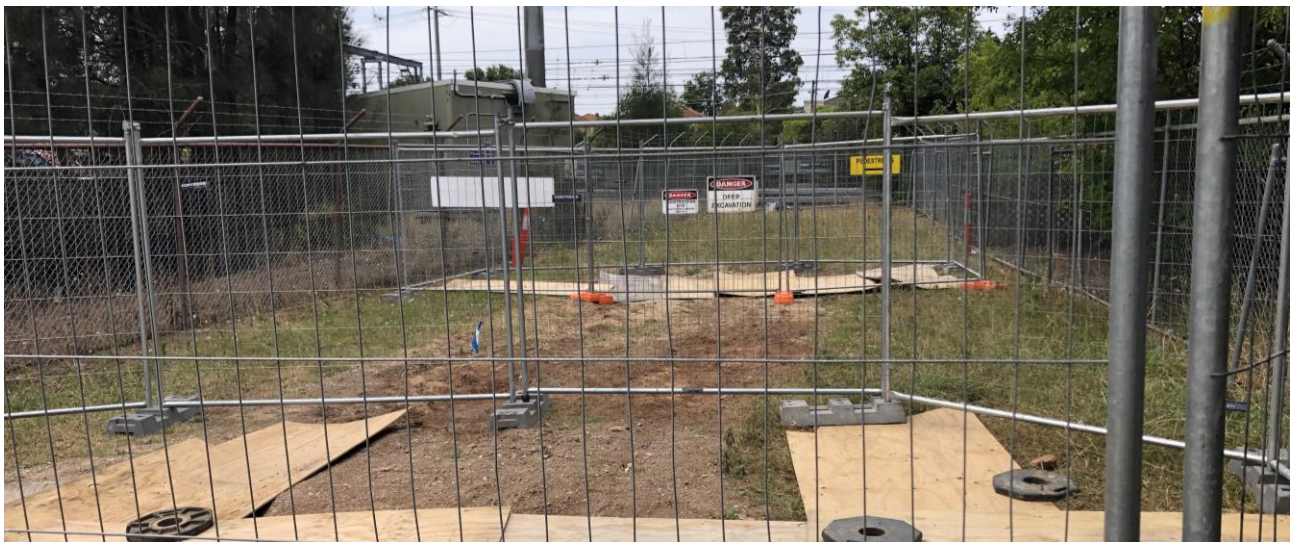
The site surface was generally flat and dry at the time of our visit, with no evidence of ponded water or elevated moisture (other than from the vacuum truck).

Slit trenching works were on-going during our visit, resulting in five (5) excavations within the boundary fence trending north-south and two (2) east-west. Outside the northern boundary fence, the five (5) slit trenches trending north-south had been excavated perpendicular to a service easement.

Plate 1 - Showing general site layout, facing east

Plate 1 below provides a general view of site conditions at time of our fieldwork.

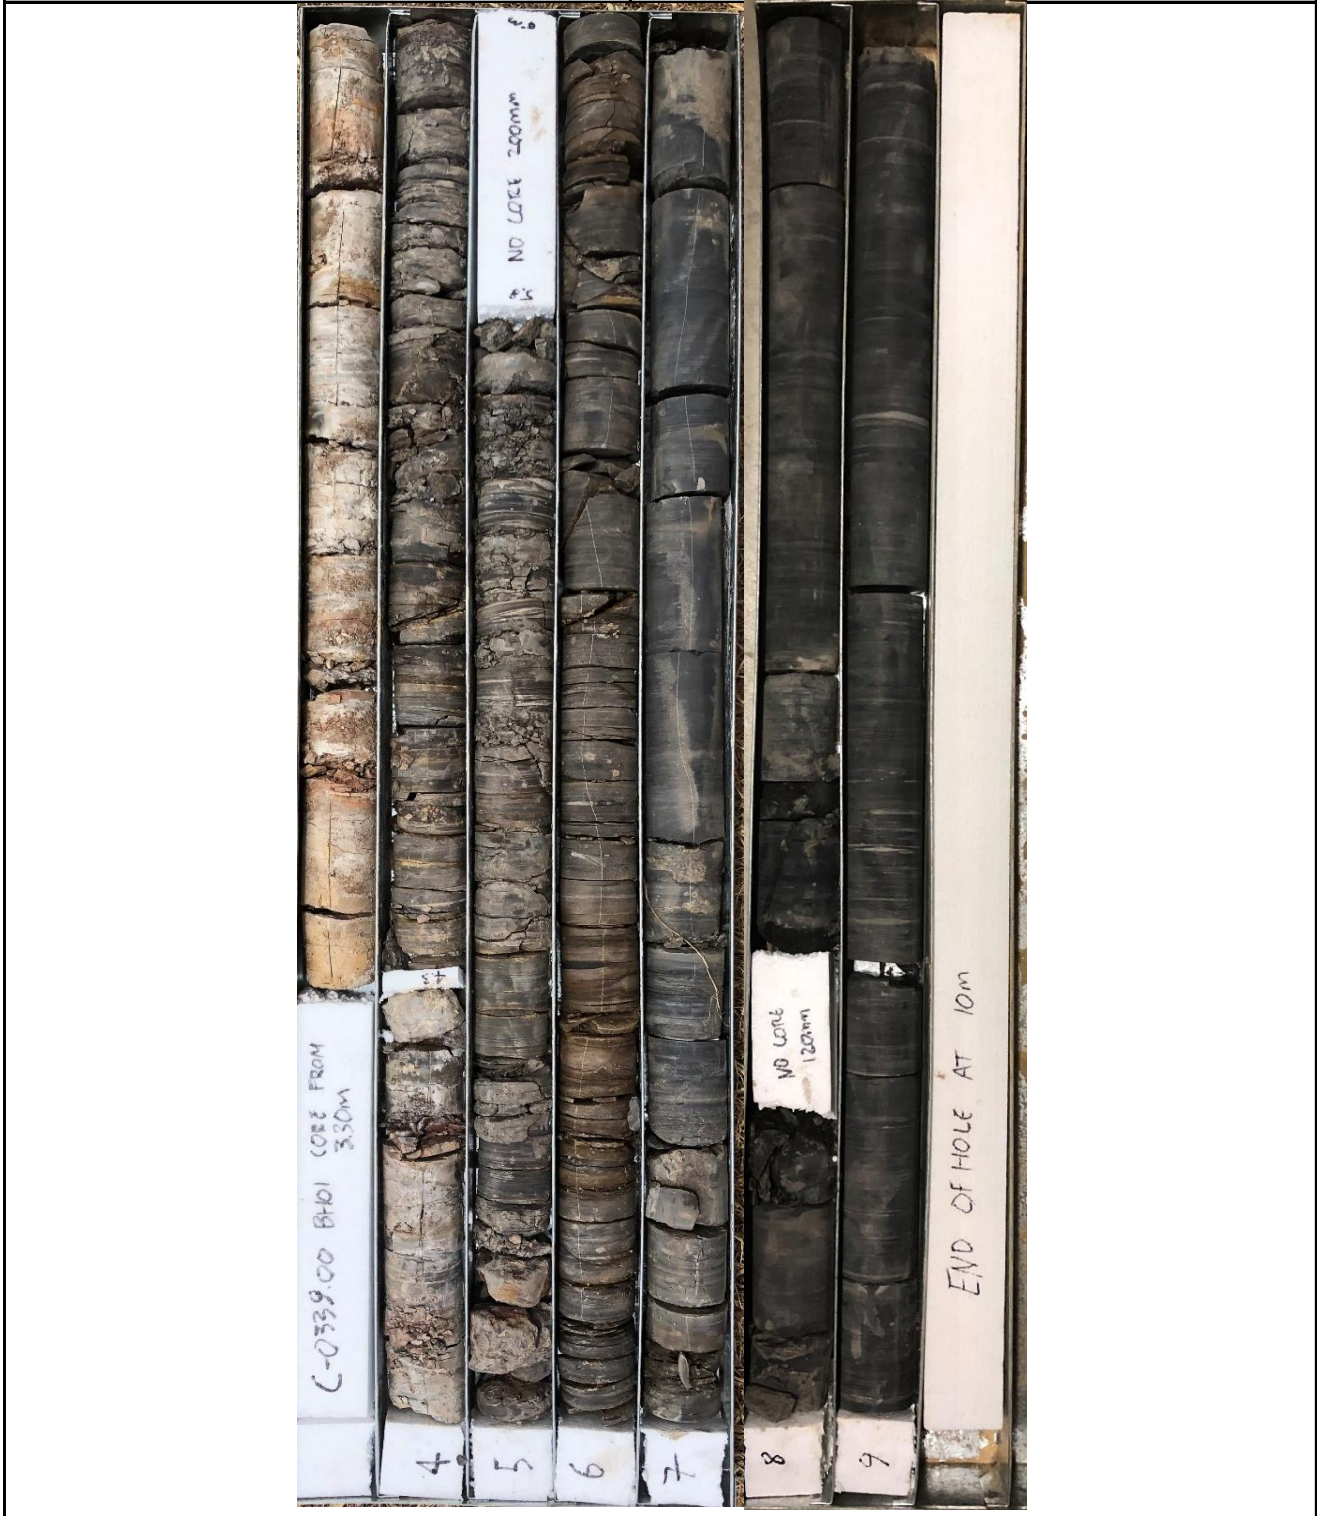
Borehole ID. **BH02**

Client: Zinfra Pty Ltd	Date: 26 November 2019
Principal: Ausgrid	By: LC
Project: Concord West Substation	Location: 31 George St, NSW

Engineering Log - Borehole

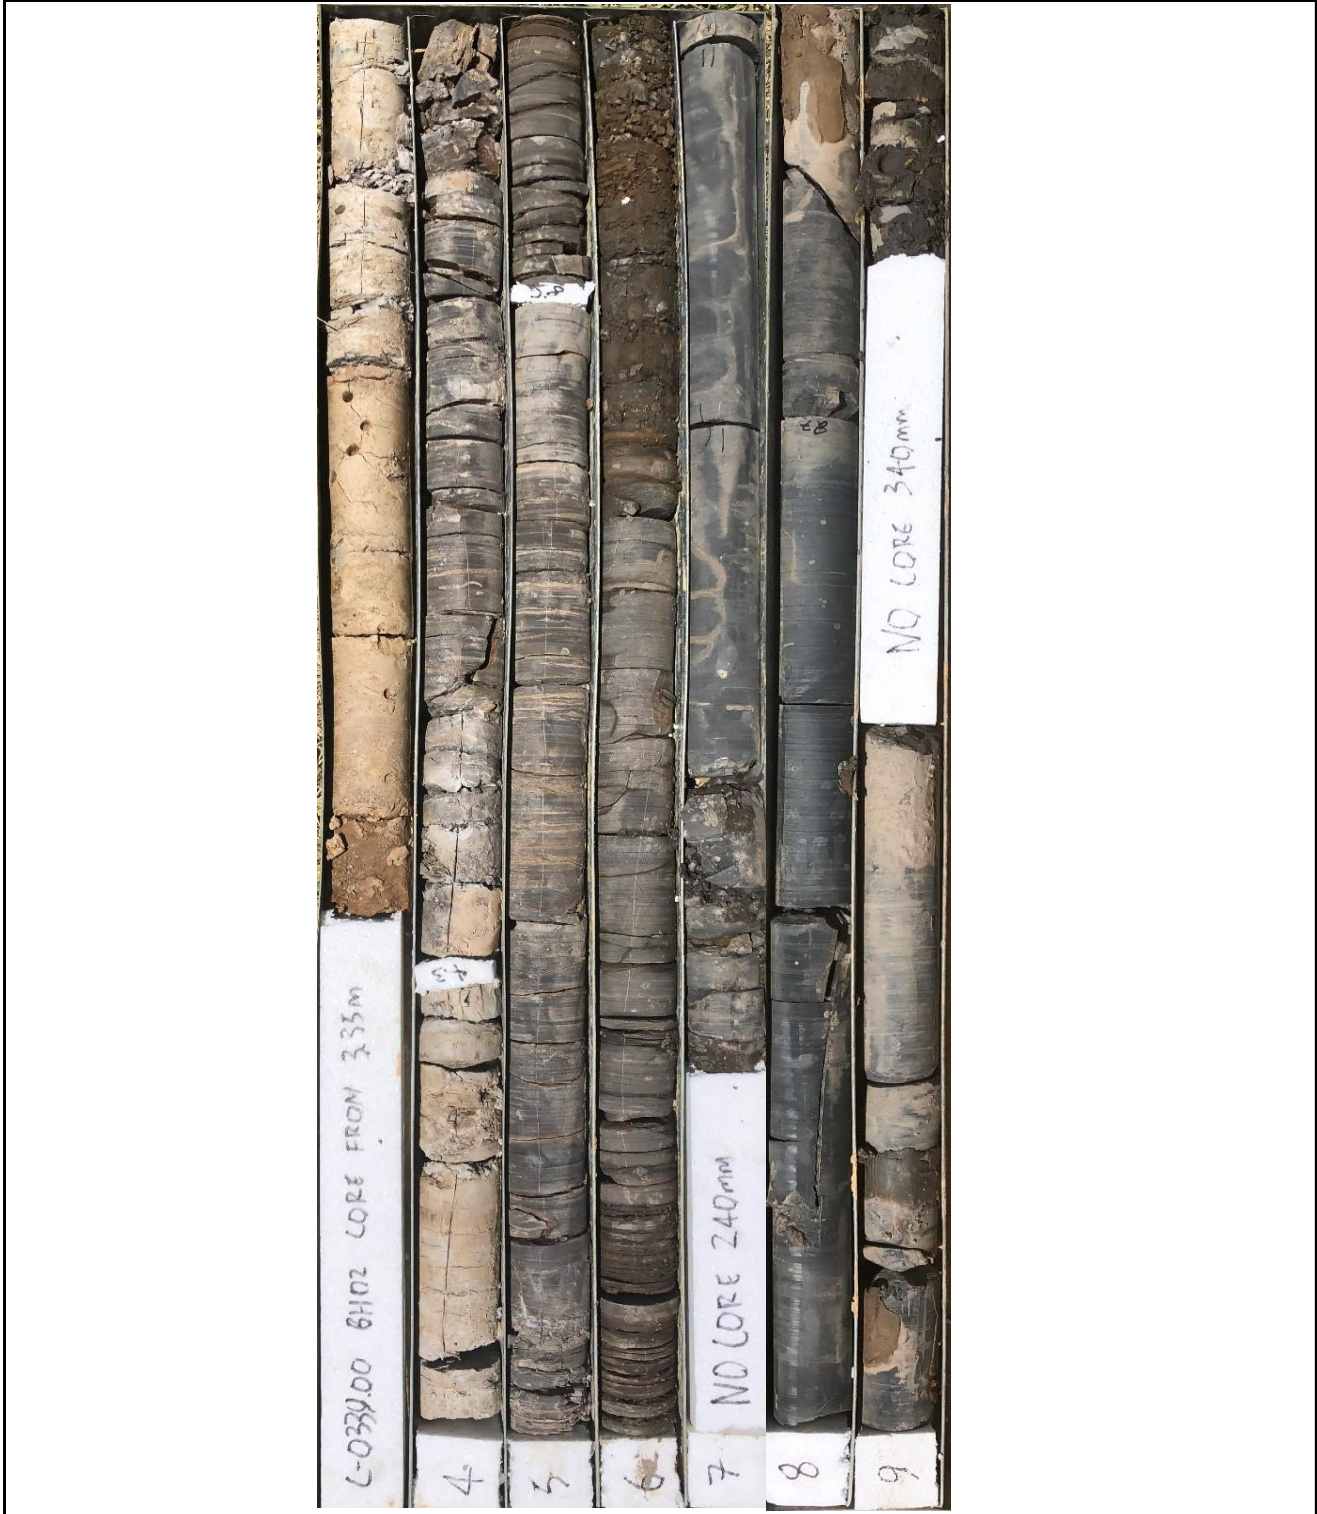
Borehole ID. **BH03**

Client: Zinfra Pty Ltd	Date: 27 November 2019
Principal: Ausgrid	By: LC
Project: Concord West Substation	Location: 31 George St, NSW

Engineering Log - Borehole
