Network Standard

NS179

Vegetation Management

Approved Date	6/08/2024	Revision	3	
Lifecycle Stage	Operations & Maintenance	Internal Use	<input checked="" type="checkbox"/>	External Use <input checked="" type="checkbox"/>
Technical Approver		Authorised By		
Name	Duminda Thenuwara	Name	Murray Chandler	
Designation	Senior Engineer	Designation	Head of Network Strategy & Future Grid

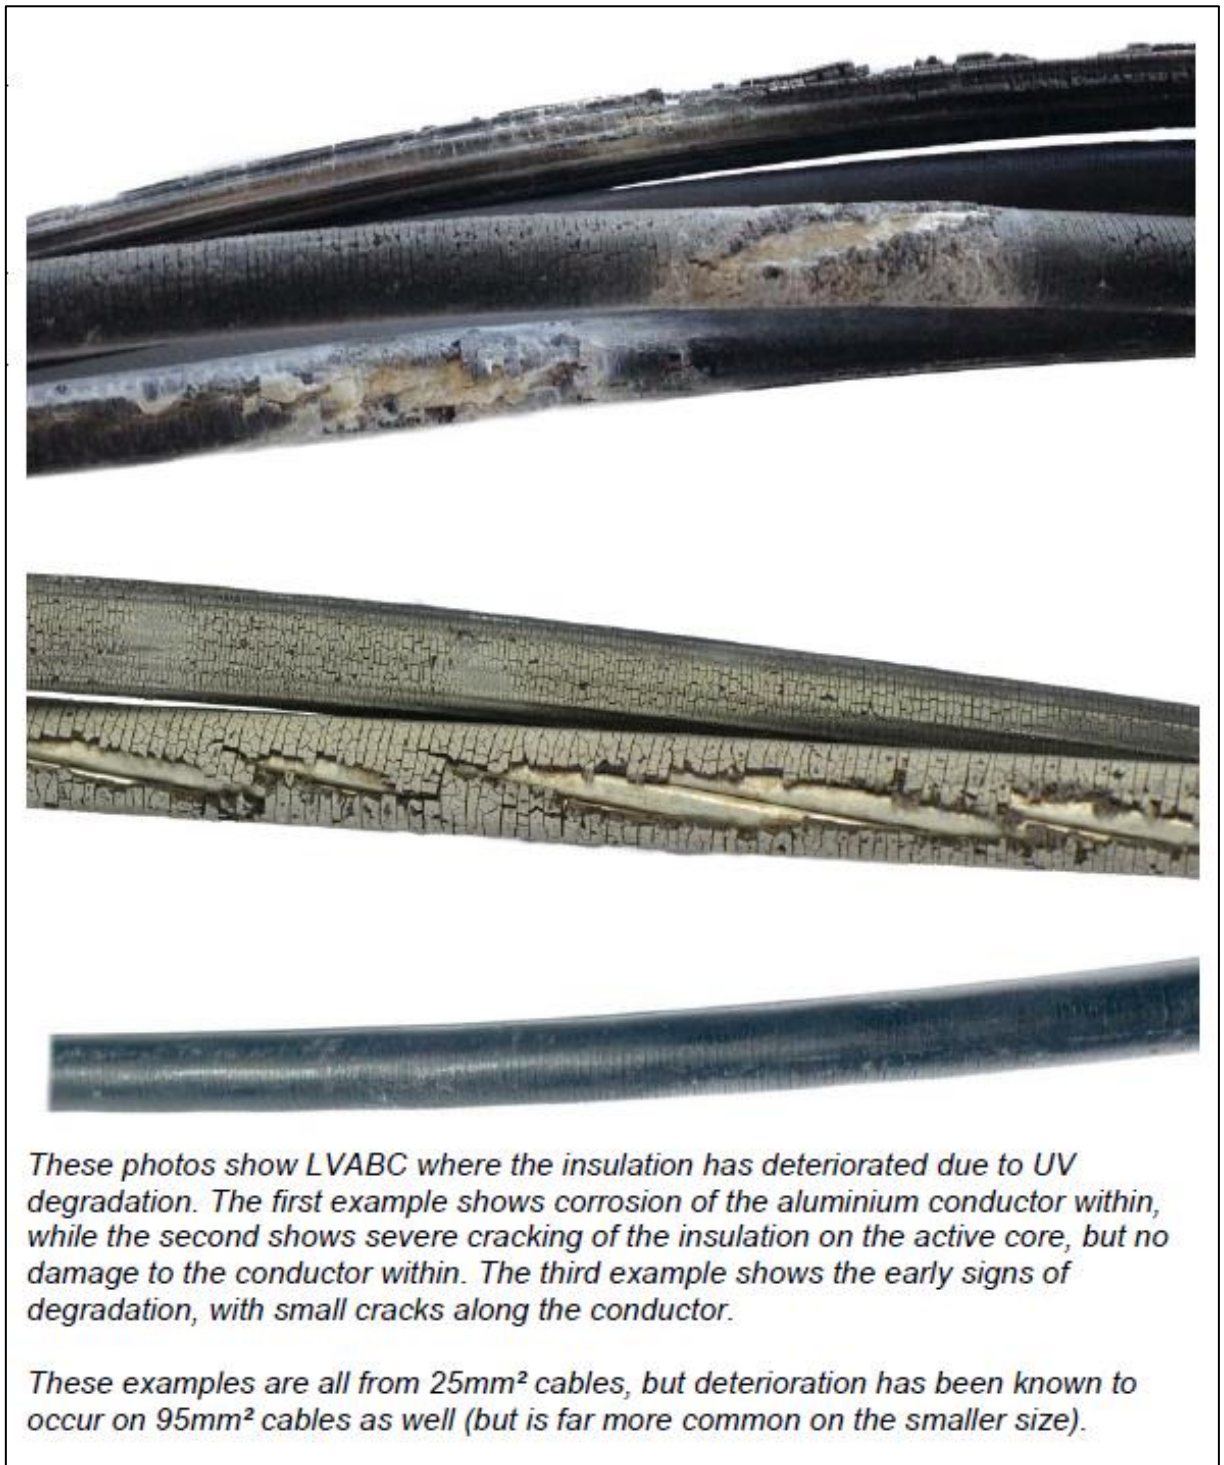
Figure 1

A1 The following figures show various reportable defects affecting ABC cables.

- a visual inspection confirms that the XLPE insulation or communications cable sheath is intact and not damaged by abrasion, degraded by ultraviolet (UV) exposure (discoloured, crazed, missing), damage by wildlife (cockatoos, etc.) (refer Annexure A for examples of LV ABC in unacceptable condition); and

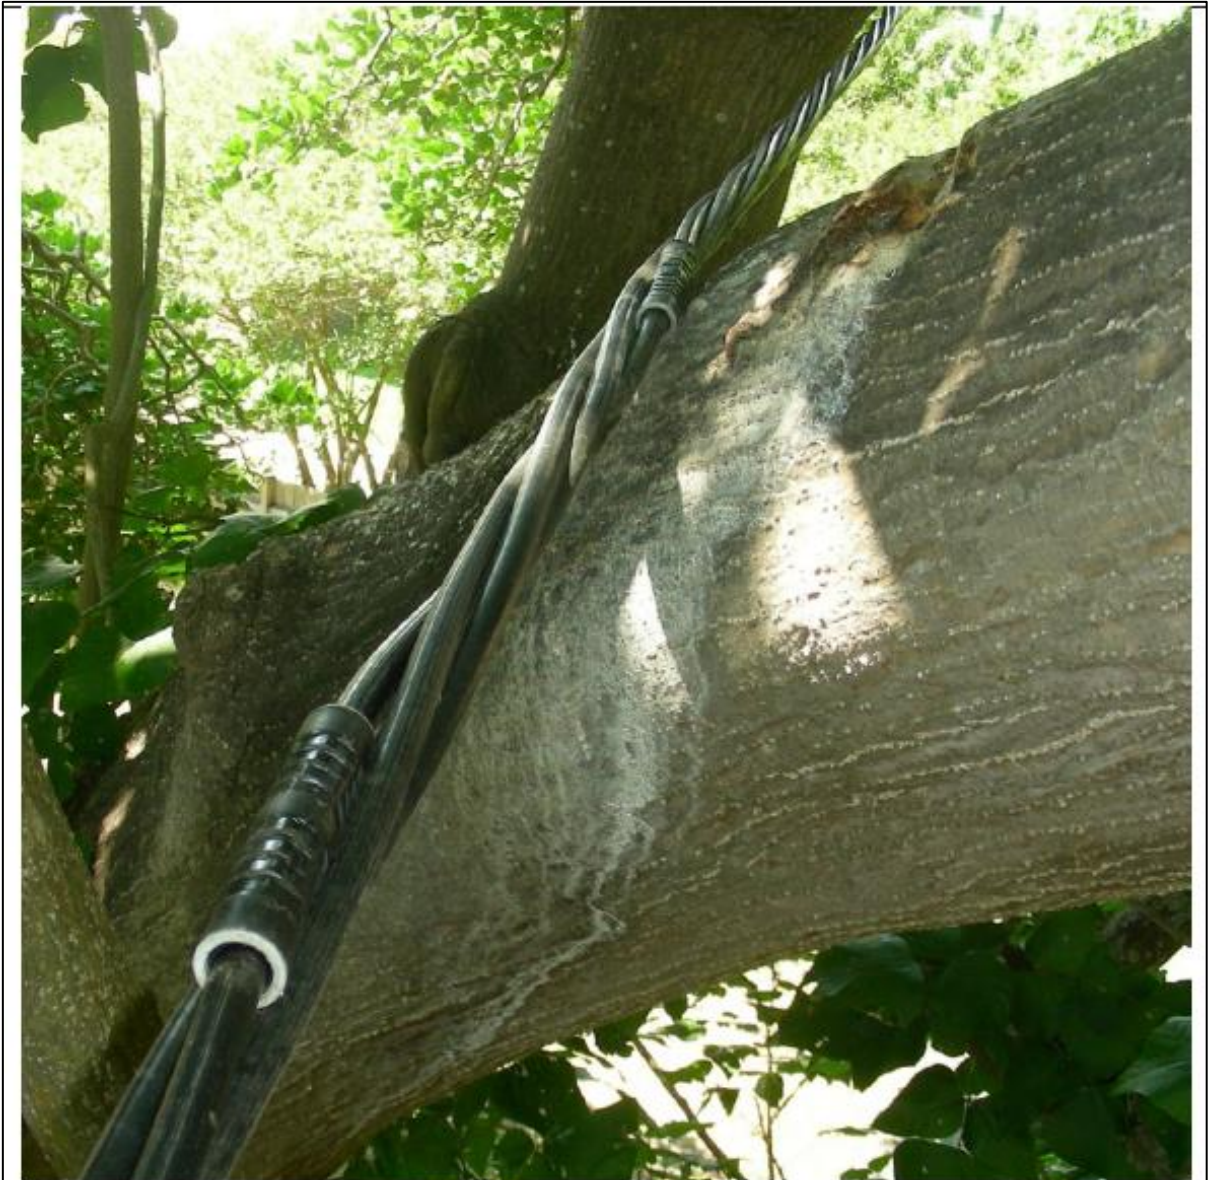
Figure 2

This photo shows damage to a tree branch and the repairs made to an LVABC cable following abrasion (a new piece of cable has been spliced in for the phase that was damaged). The insulation on LVABC is very tough, but can eventually wear through, damaging the cable, the tree, and having potential impacts on safety and reliability.

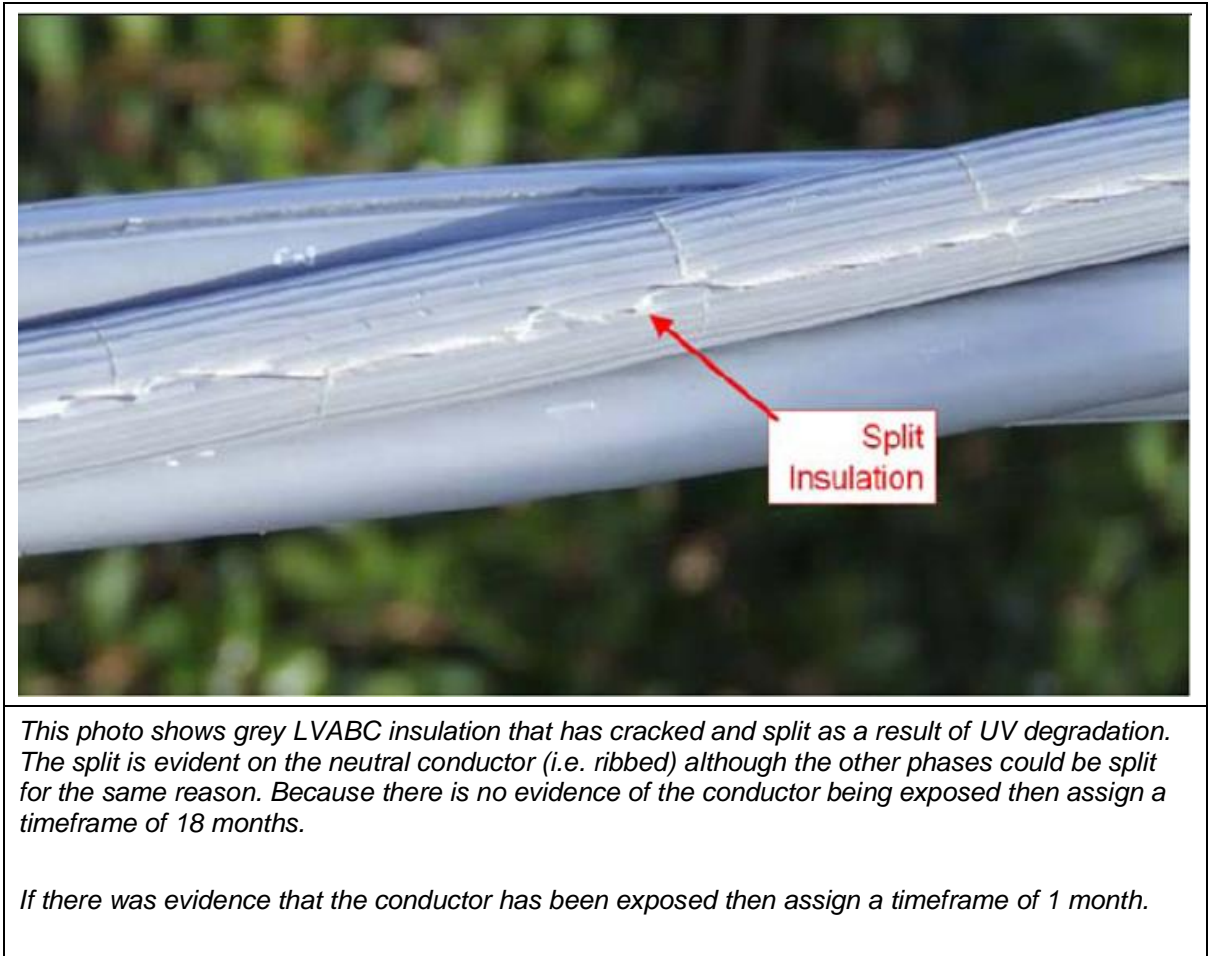
Figure 3

Note: examples shown are for LV ABC only, but valid for HV ABC too.
