# Network Standard

**NS179**

**Vegetation Management**

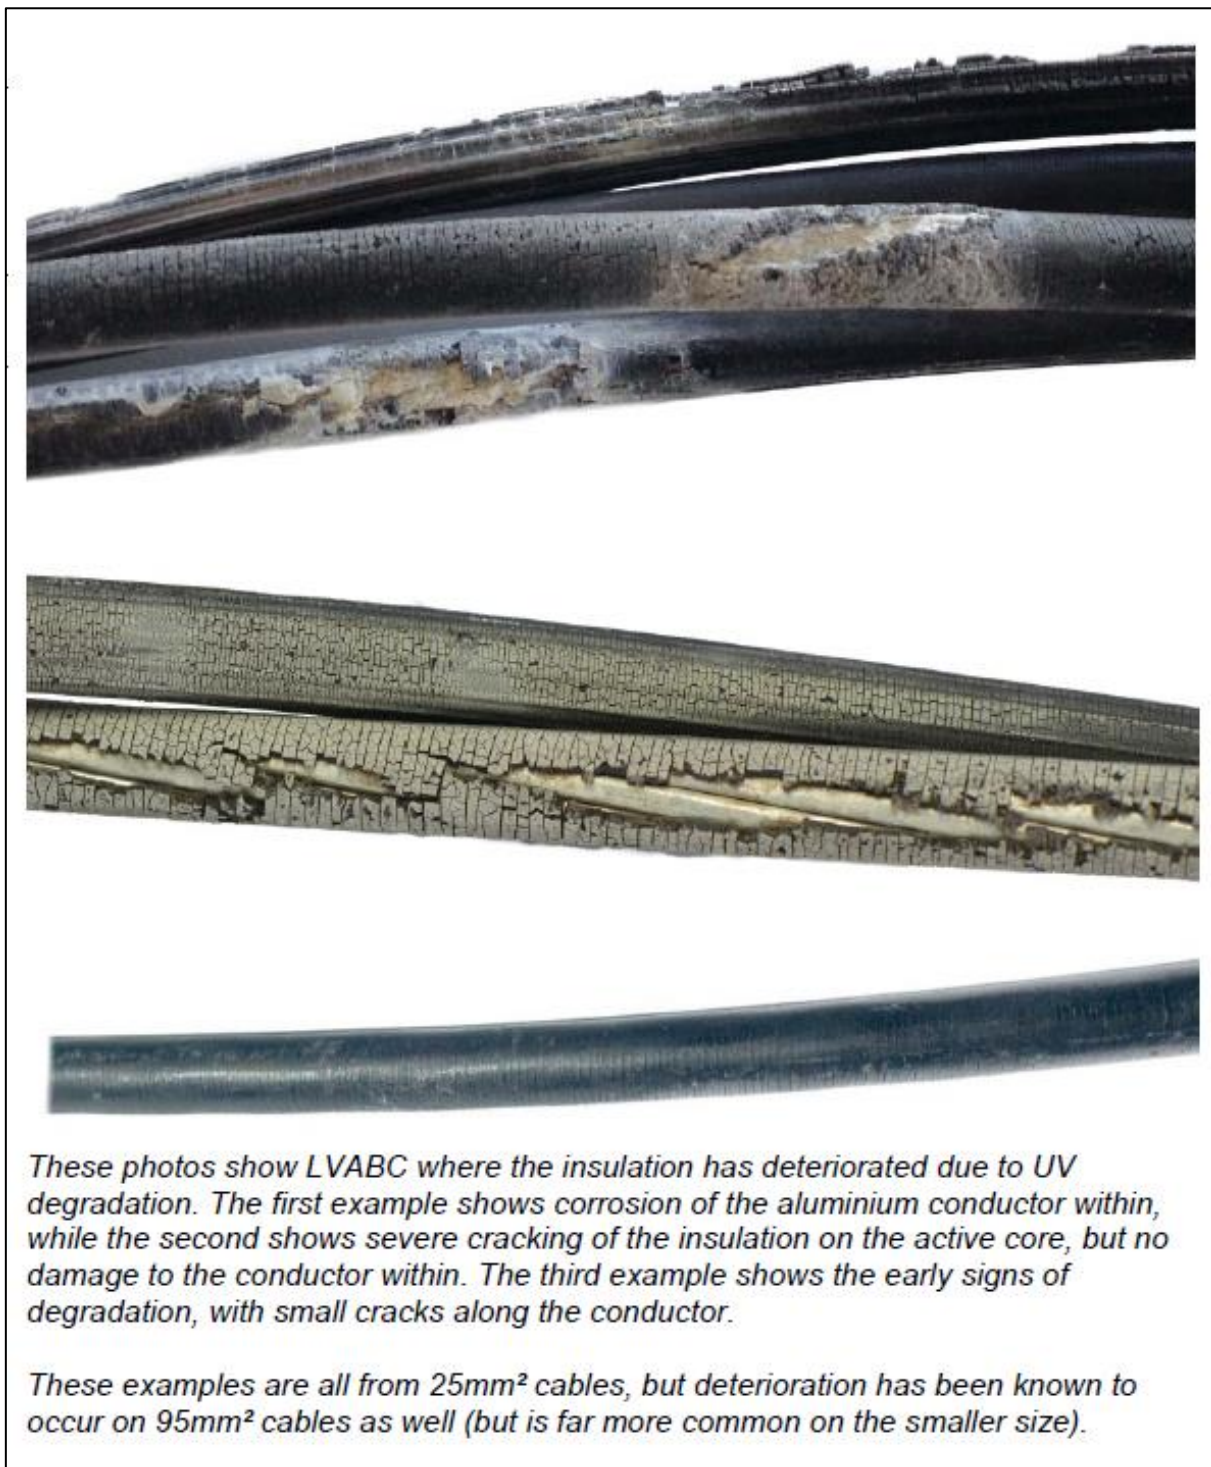
Figure 1

A1 The following figures show various reportable defects affecting ABC cables.

- a visual inspection confirms that the XLPE insulation or communications cable sheath is intact and not damaged by abrasion, degraded by ultraviolet (UV) exposure (discoloured, crazed, missing), damage by wildlife (cockatoos, etc.) (refer Annexure A for examples of LV ABC in unacceptable condition); and

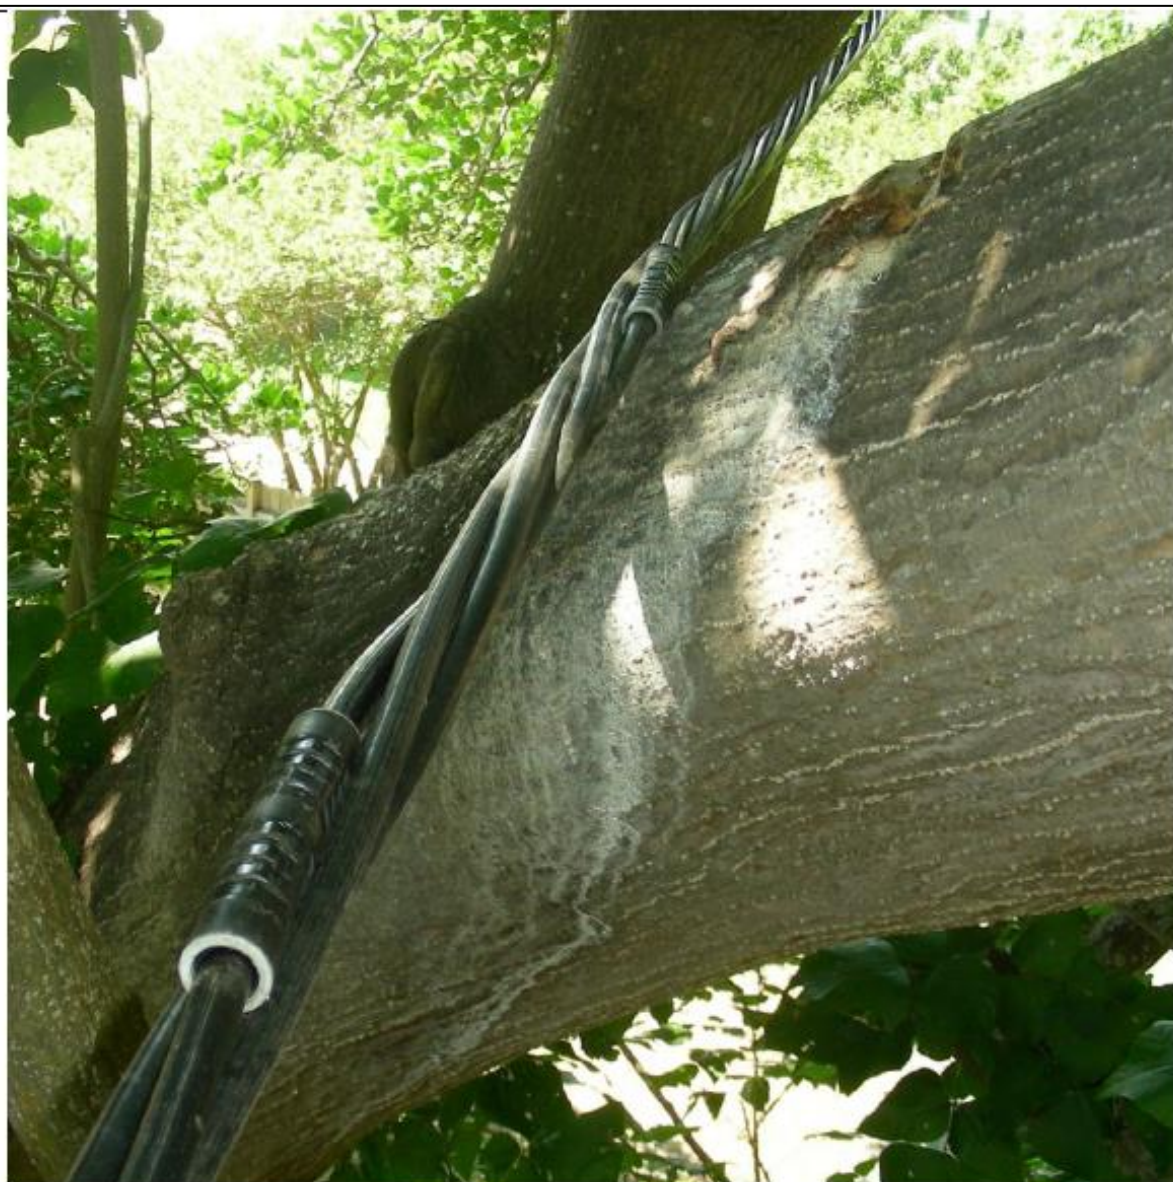
Figure 2

*This photo shows damage to a tree branch and the repairs made to an LVABC cable following abrasion (a new piece of cable has been spliced in for the phase that was damaged). The insulation on LVABC is very tough, but can eventually wear through, damaging the cable, the tree, and having potential impacts on safety and reliability.*

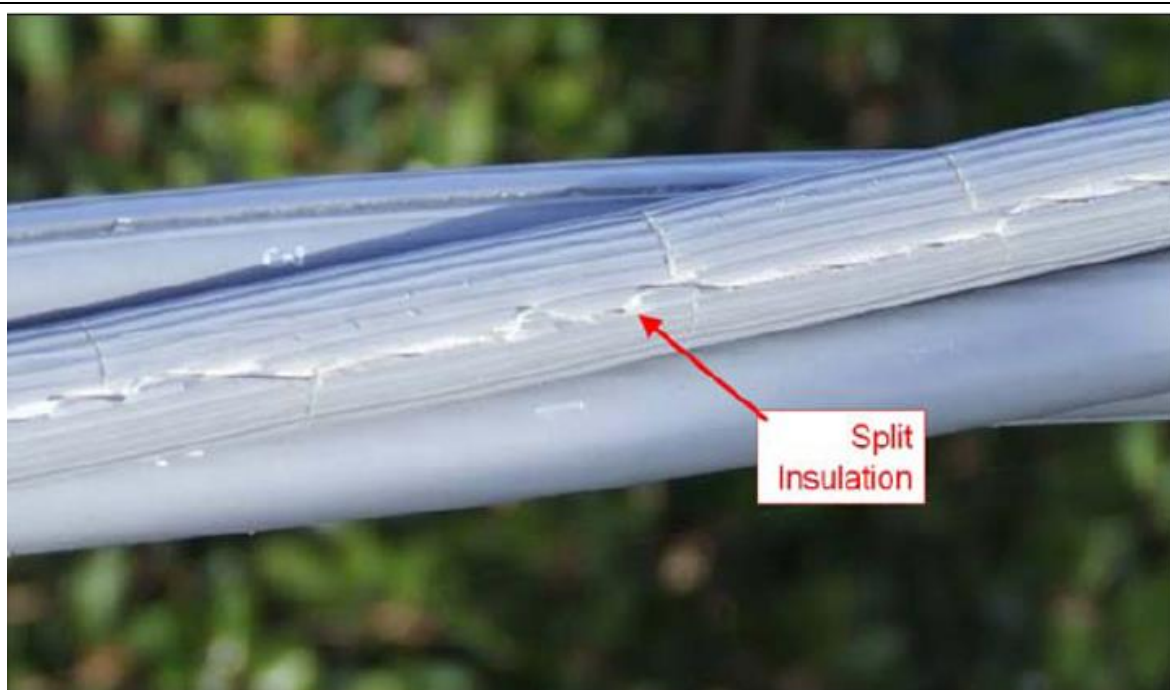
**Figure 3**

*This photo shows grey LVABC insulation that has cracked and split as a result of UV degradation. The split is evident on the neutral conductor (i.e. ribbed) although the other phases could be split for the same reason. Because there is no evidence of the conductor being exposed then assign a timeframe of 18 months.*

*If there was evidence that the conductor has been exposed then assign a timeframe of 1 month.*
