**RE: Tree inspection- 1 x *Celtis sinensis*- Chinese Hackberry.**

This letter has been provided to discuss the recently completed inspection of a semi-mature *Celtis sinensis*- Chinese Hackberry, located within the rear of 27-29 George Street, on the Southern boundary of the subject site.

Our brief was to inspect the tree and provide details regarding the tree protection zone (TPZ) and structural root zone (SRZ) and also quantify the level of impact that would likely result from pruning the tree back to the property boundary to enable construction of a new building.

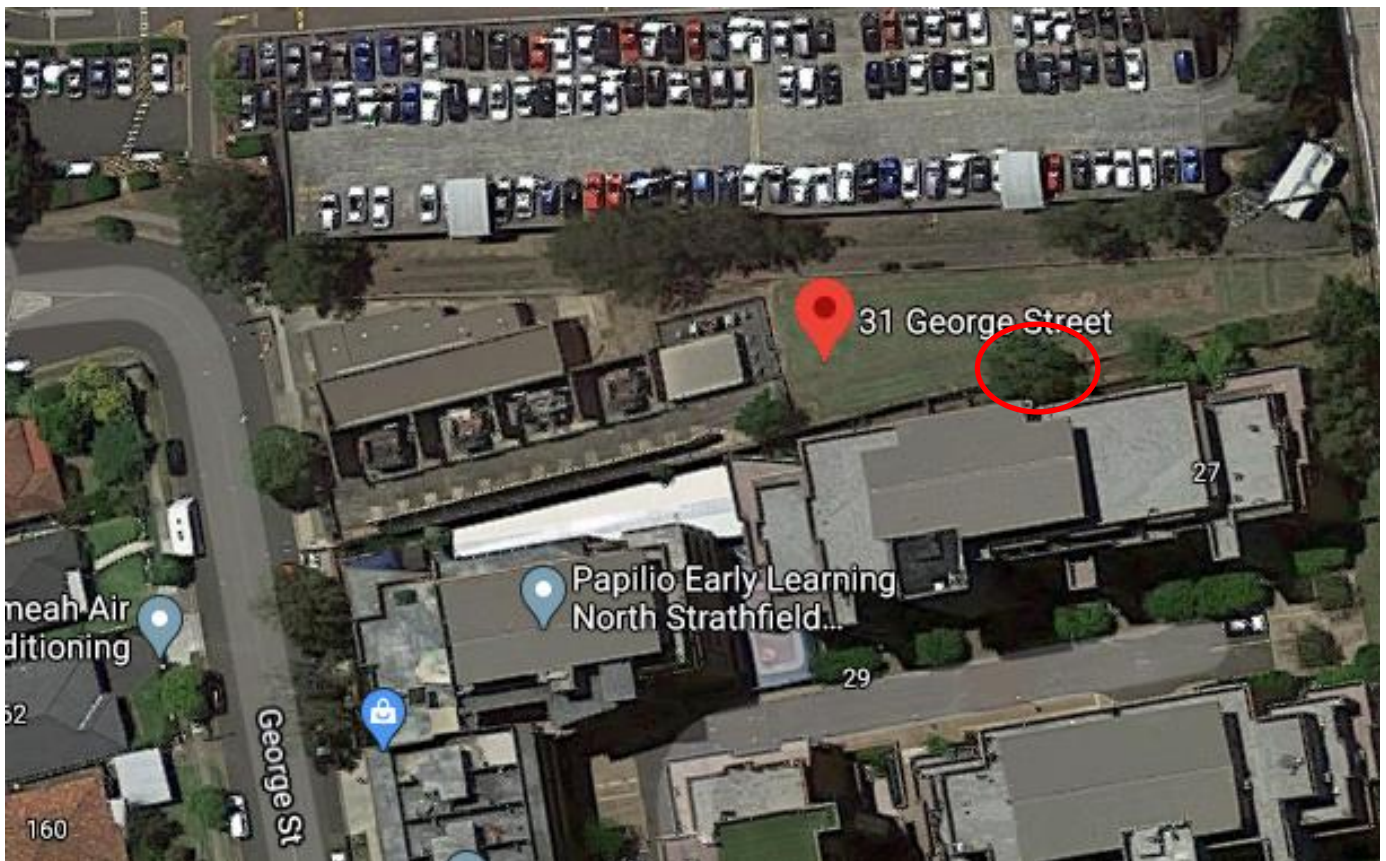
Figure 1: The subject tree (circled Red), located on the Southern boundary of the property. Image from Google Maps 2020.
