Network Standard

Document No. Title: NS146 Assessment Procedure For Working On Poles

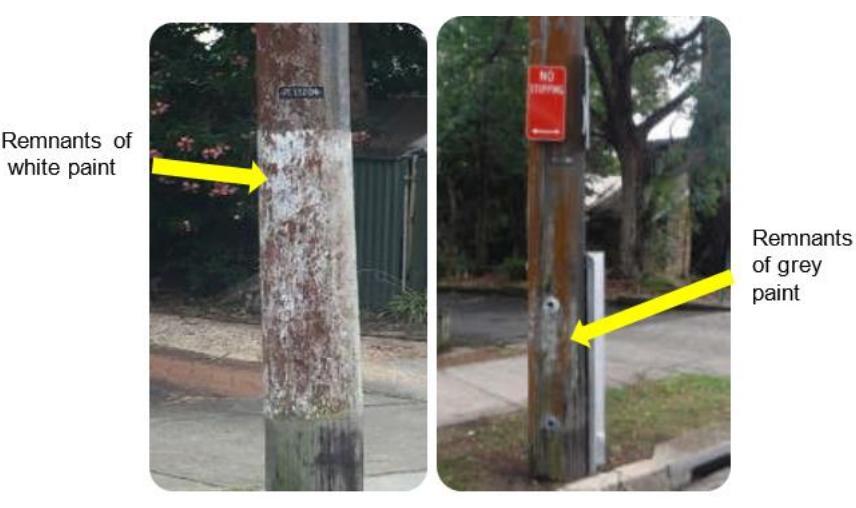
Figure 1 – Examples of Poles with Remnant Friable Asbestos Paint

All poles tested have been recorded on the Asbestos Register and in GIS including those where no asbestos was present. Poles confirmed as containing asbestos paint are typically prioritised for replacement. Where a pole is found with 'grey', 'white' or 'black' paint and it is not listed in the Asbestos Register or GIS, contact the Hazardous Materials Hotline on 02-9394 6961 to arrange testing before planned work is undertaken.

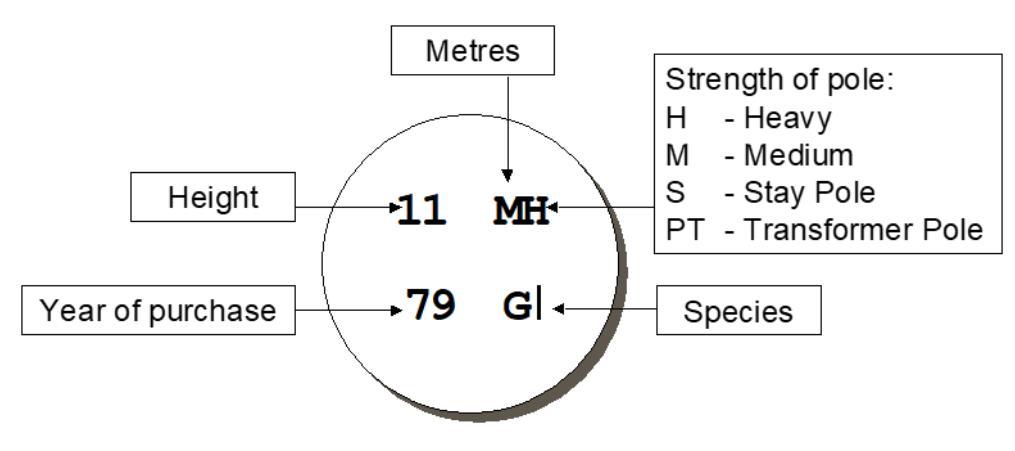
An example of a pre-1982 disc is shown below. This disc shows an 11 metre, heavy grey ironbark pole purchased in 1979.

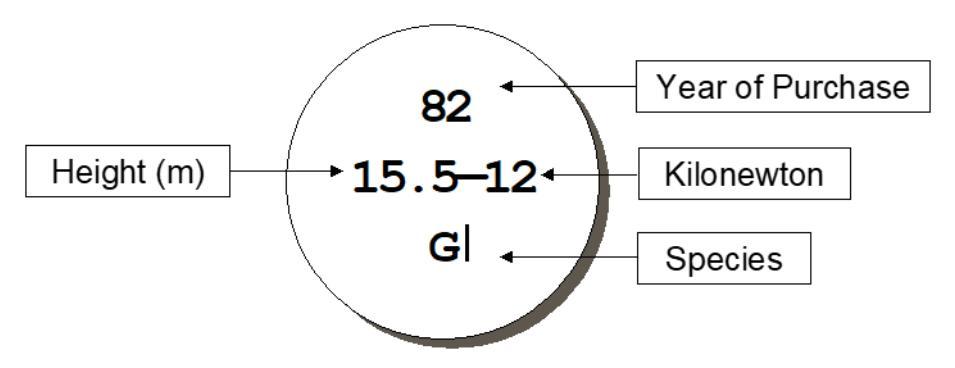
Figure 3 – Example of a 1982 - 1988 pole disc

An example of a 1982 - 1988 disc is shown below. This disc shows a 15.5 metre grey ironbark pole rated at 12kN, purchased in 1982.

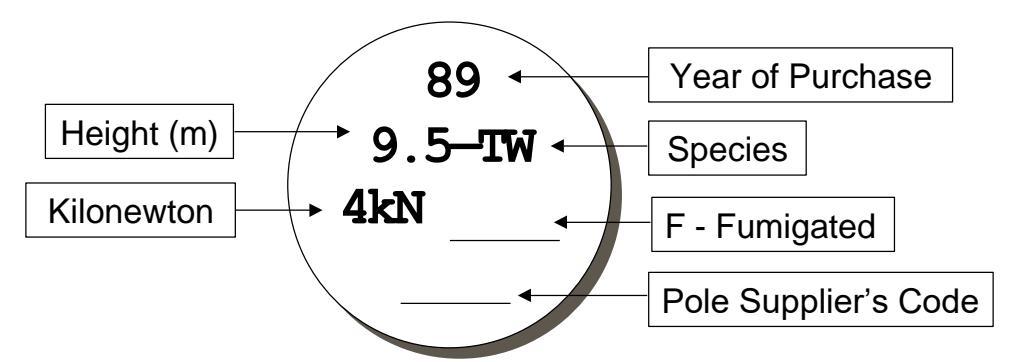
Figure 4 – Example of a pole disc from 1988 onwards

An example of a 1988 onwards disc is shown below. The disc shows a 9.5 metre tallowwood pole rated at 4 Kilonewton purchased in 1989. As there is no code, you can assume that the pole has not been fumigated.

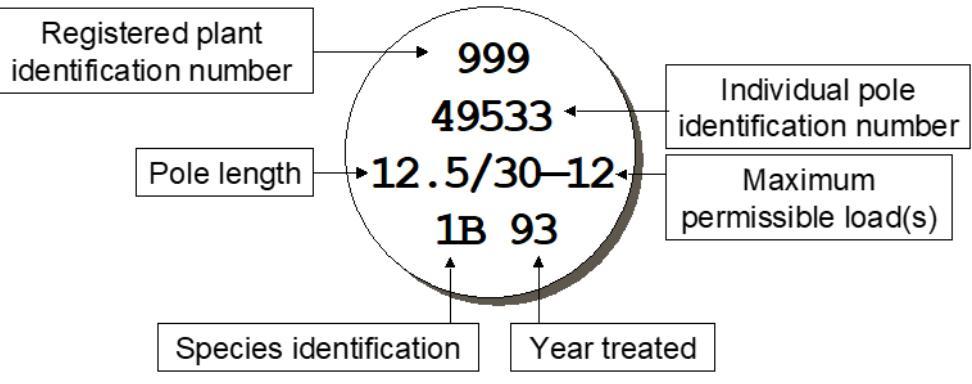
Figure 5 – Example of a pole disc from 1988 onwards (Option 1)

A number of disc options also became available to record additional information on the disc. Examples of these options are shown below.

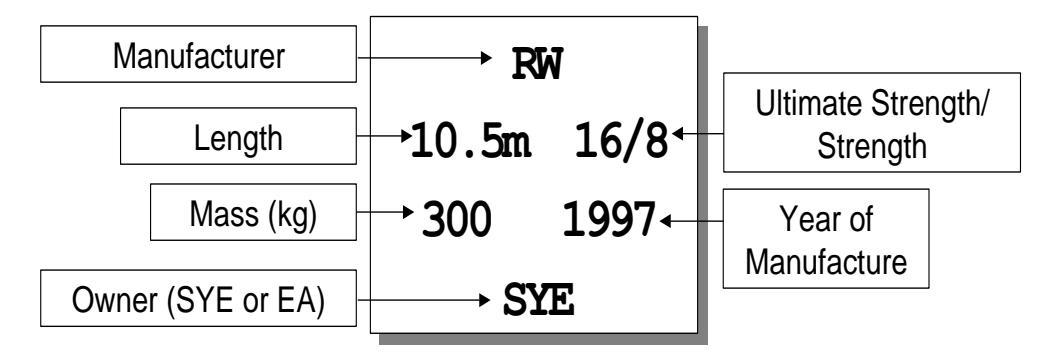
Figure 8 – Example of a concrete pole disc

A diagram of a concrete pole disc is shown below.

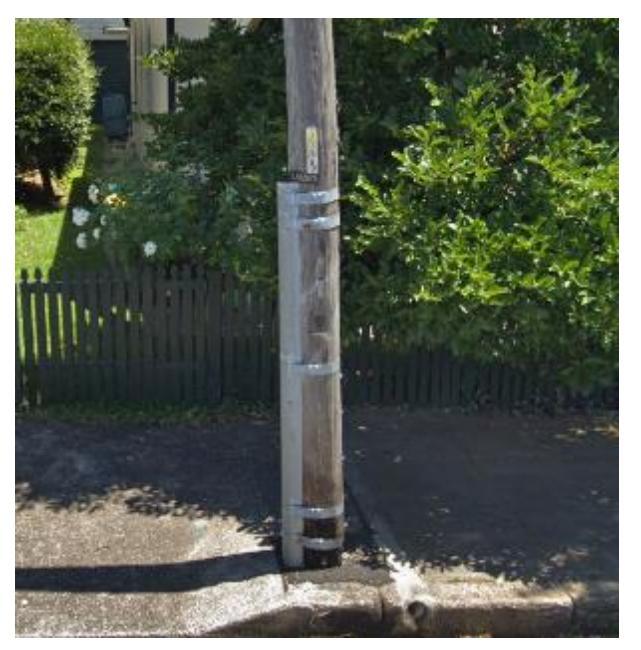
Figure 9 – Example of an Ausmose Oz-C splinted reinforced pole

The Ausmose Oz C Splint is a steel 'C' section channel made from 6mm thick galvanised steel. They vary in length from 3.1 to 3.4 metres and are secured to the pole using four or more 52mm wide galvanised steel bands. Poles reinforced with Ausmose Oz C splints require at least 25% residual strength below groundline to provide the required support for the pole.

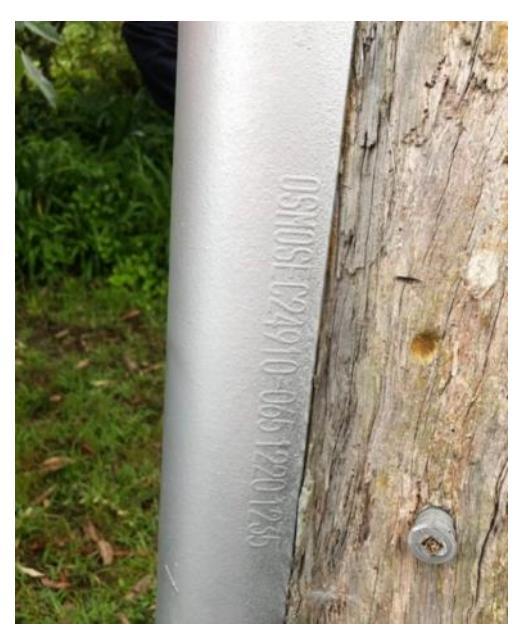
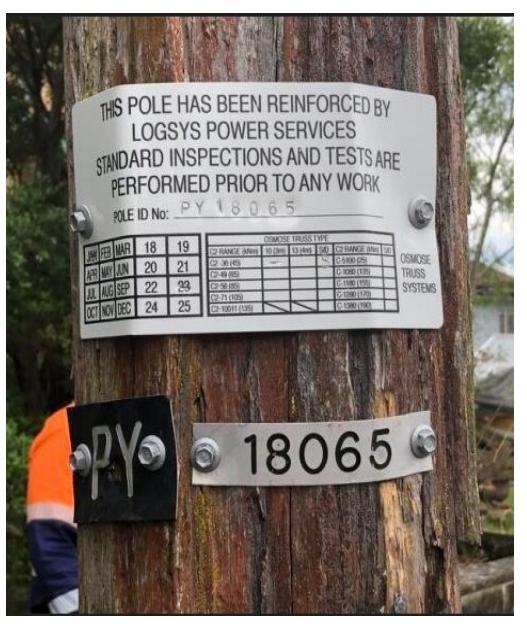
Figure 10 – Examples of Osmose Osmo-C-Truss embossed details and pole label

The Osmose (Logsys) 'Osmo-C-Truss' or 'Osmo-C2-Truss' splints are of similar appearance and design to Ausmose Oz C splints however, the splints are embossed vertically along the above ground length of the splint with the splint details and a label for the splint details is attached to the pole above the splint (refer to Figure 10). Osmo-C-Truss splints are typically used for poles with a large diameter and Osmo-C2-Truss splints are used for typical distribution poles due to their lighter weight design.

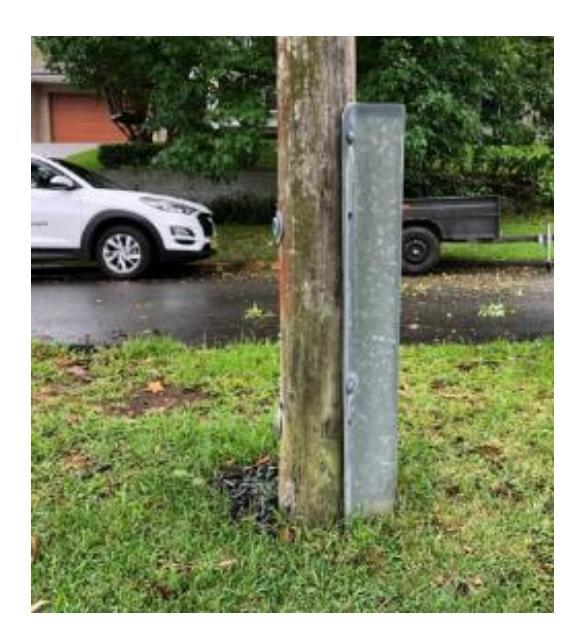
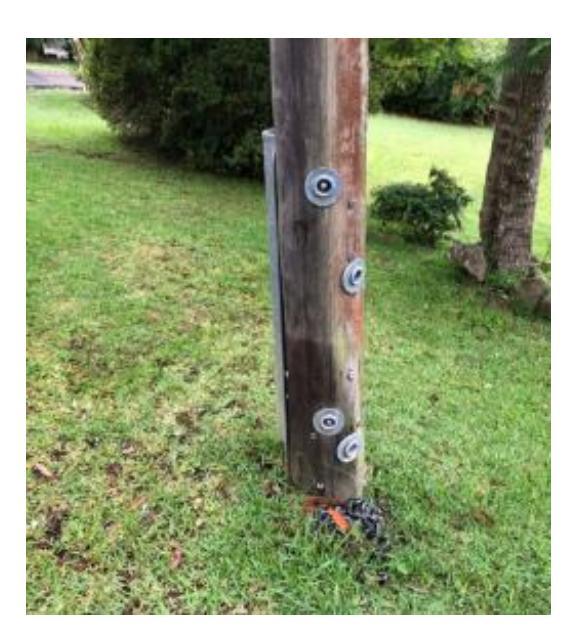
Figure 11 – RFD nail secured with bolts

The securing bolts of RFD nails rigidly hold the pole in place therefore, no below ground pole inspection is considered necessary, other than an examination of the steel reinforcement to check for rust. However, because the pole can remain in service with no sound timber at groundline, care must be taken when inspecting the above ground section of the pole.

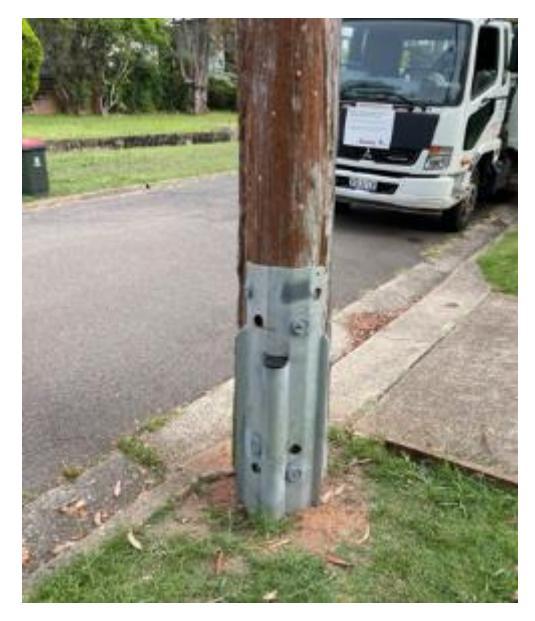
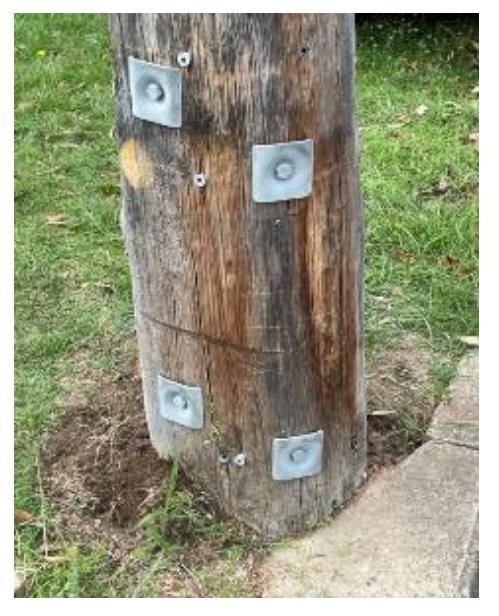
Figure 12 – Powerbeam nail secured with bolts

Powerbeam nails are now used for nail reinforcing. Powerbeam nails are pressed steel section channels made from thick galvanised steel. They vary in length from 2.4 to 3.15 metres long and are secured to the pole using four galvanised steel bolts.

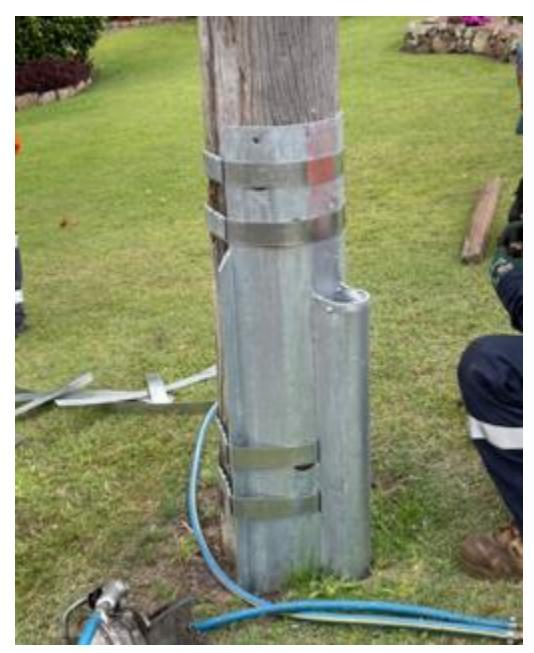
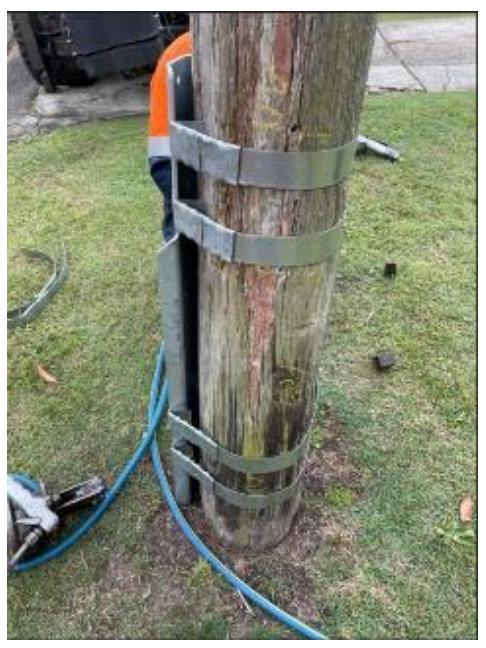
Figure 13 – Powerbeam nail secured with bands

Powerbeam nails may also be secured to the pole using 2 to 4 galvanised steel bands and are considered to be 'splinted' poles. Poles reinforced using Powerbeam nails are capable of supporting twice the pole rating with no sound timber at groundline.

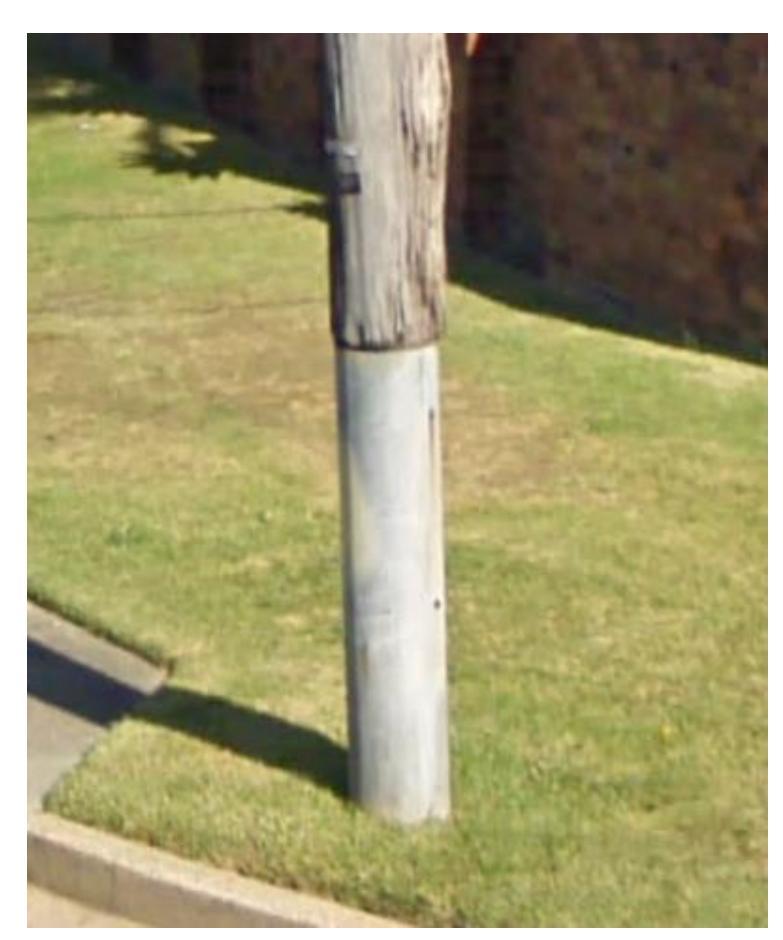
Figure 14 – Example of a composite timber pole

In both cases the timber pole is 'joined' to the concrete filled steel tube, or concrete stub with sliding steel tube, by placing the machined down section of the pole into the steel tube (sliding or fixed). The quantity of remaining composite timber poles is small as many have been replaced since the time that they were originally installed.

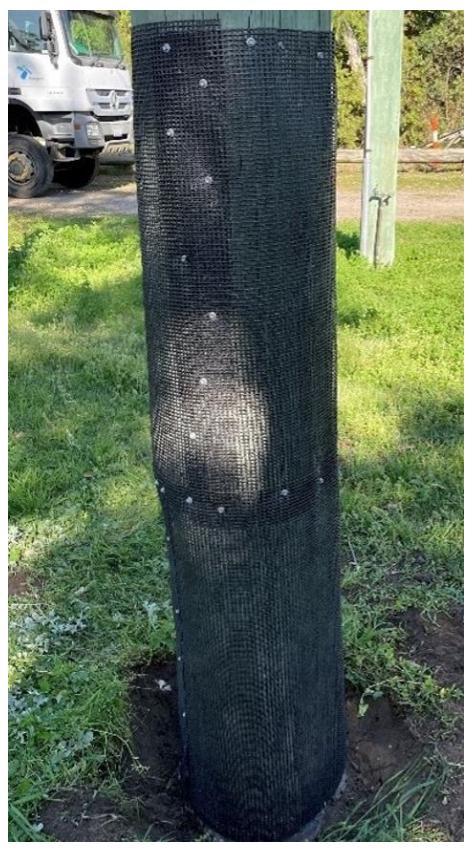
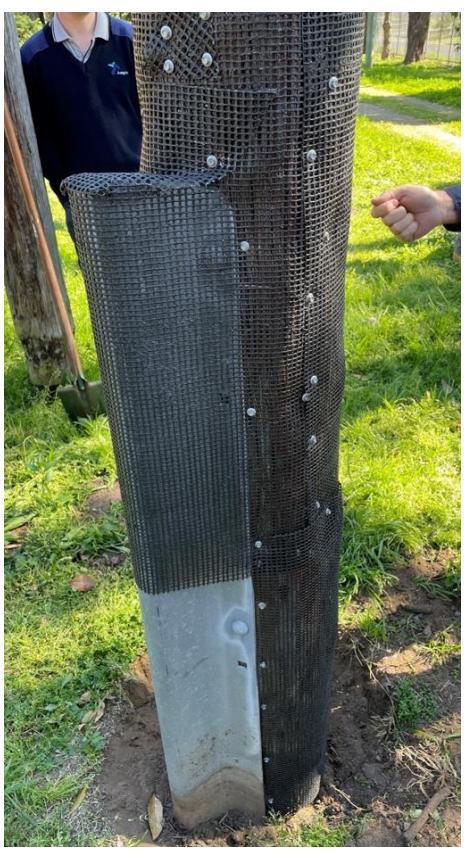
Figure 15 – Examples of Genics fire mesh installed on timber poles

pole to maintain the protective barrier when the mesh has been altered. Sounding of the pole can be performed with the mesh in place.

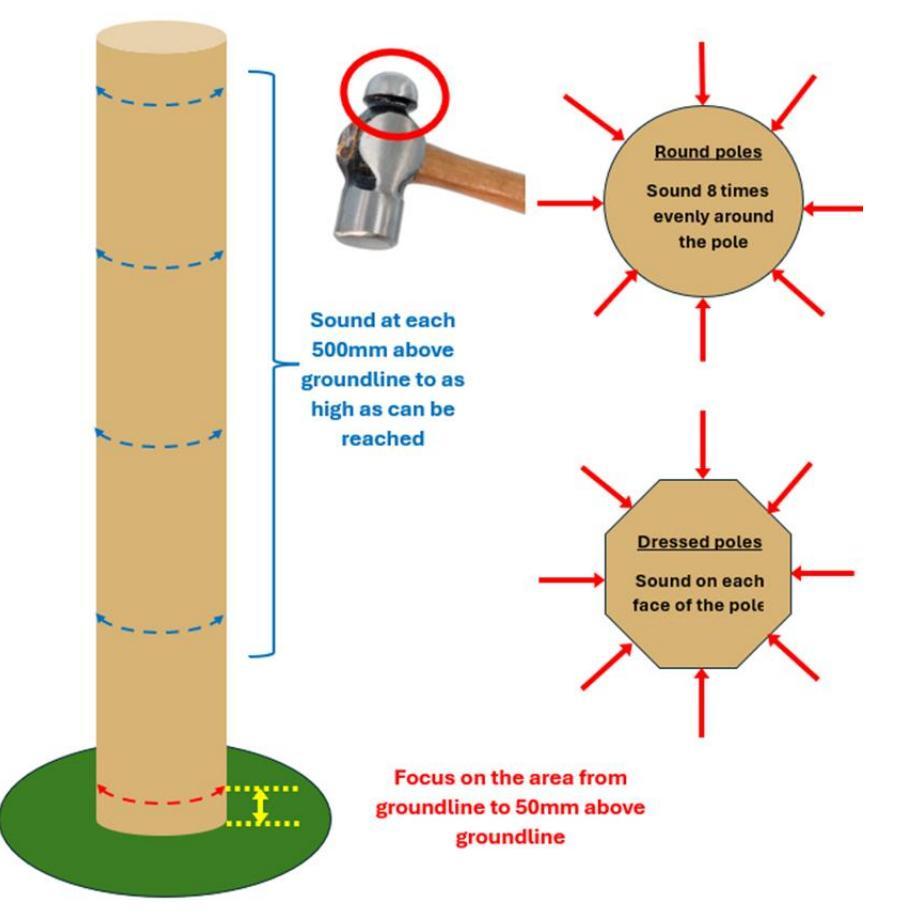
Figure 17 – Sounding above groundline with a ball pein hammer

Sounding prior to excavation (above ground sounding) shall extend from groundline (with additional focus on the portion within 50mm of groundline) to as high as can comfortably be reached (generally 2m above groundline). To sound a pole so that an internal defect is not missed it is necessary to perform at least 8 soundings (strikes) around the circumference of a round pole, or one on each flat face of a dressed pole, within 50mm of groundline, then repeat this at least 4 times around the pole at each 500mm interval above groundline to as high as can be comfortably reached. Reinforced poles shall be thoroughly sounded in the vicinity of securing bands or bolts.

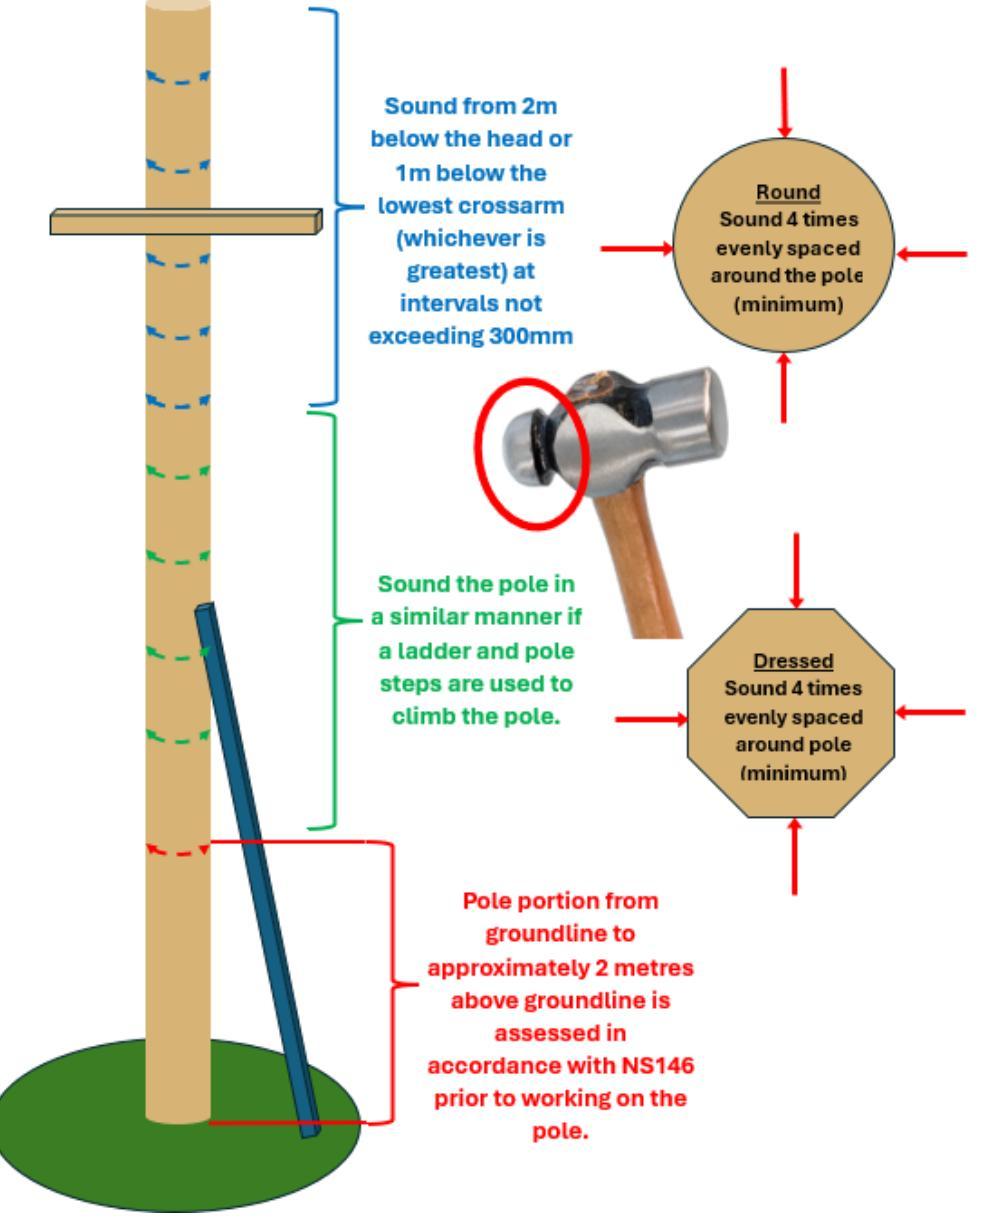
To sound the upper portions of a timber pole so that an internal defect is not missed it is necessary to perform at least 4 soundings with the ball of a ball pein hammer at the one plane (level) around the circumference of a round pole, or evenly around the flat faces of a dressed pole, then repeat this at intervals not exceeding 300mm from the previous plane sounded. Again, some poles will need to be sounded at much closer intervals where a defect is indicated. If the pole is being accessed using a ladder and pole steps, repeat sounding as above as the pole is climbed and at other defect locations identified or suspected from visual inspection

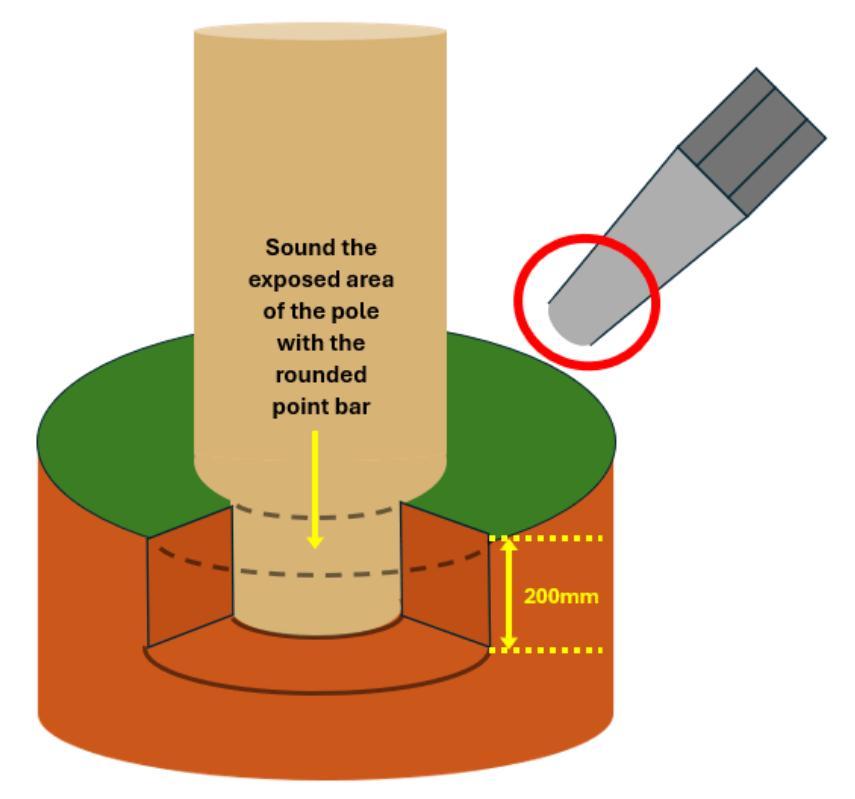
Figure 19 – Sounding below groundline with a rounded point bar

When the pole has been partially excavated, the exposed portion of the pole shall be struck with the rounded point bar to thoroughly sound the pole for internal defects within 50-100mm below groundline.

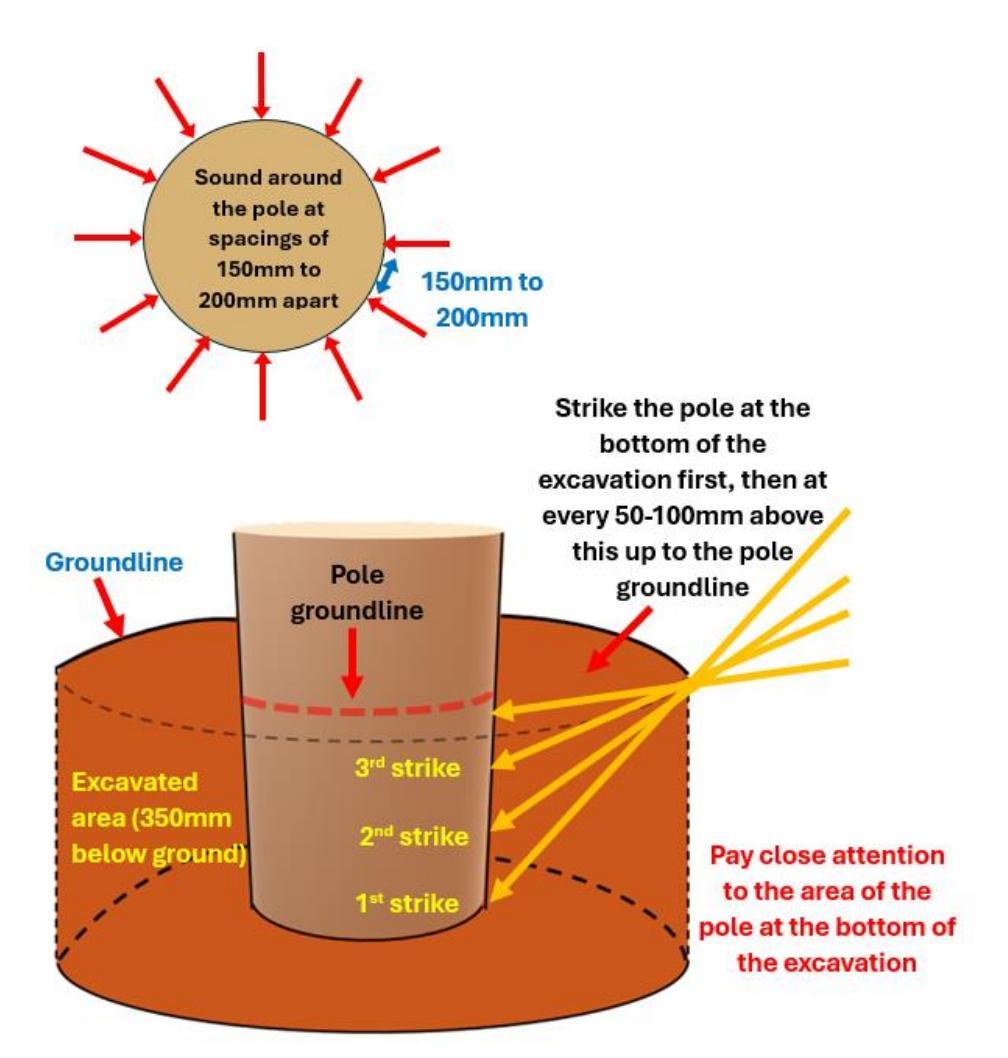
Figure 20 – Sounding below groundline with a rounded point bar

- After testing at the base of the excavation, the bar shall then be used to impact the pole immediately above this point, then test again every 50-100mm in a vertical line up to groundline. The pole shall be tested in this manner at least every 150-200mm around the pole. It is critical that this procedure be performed rigorously and methodically to make certain of the safety and strength of the pole.

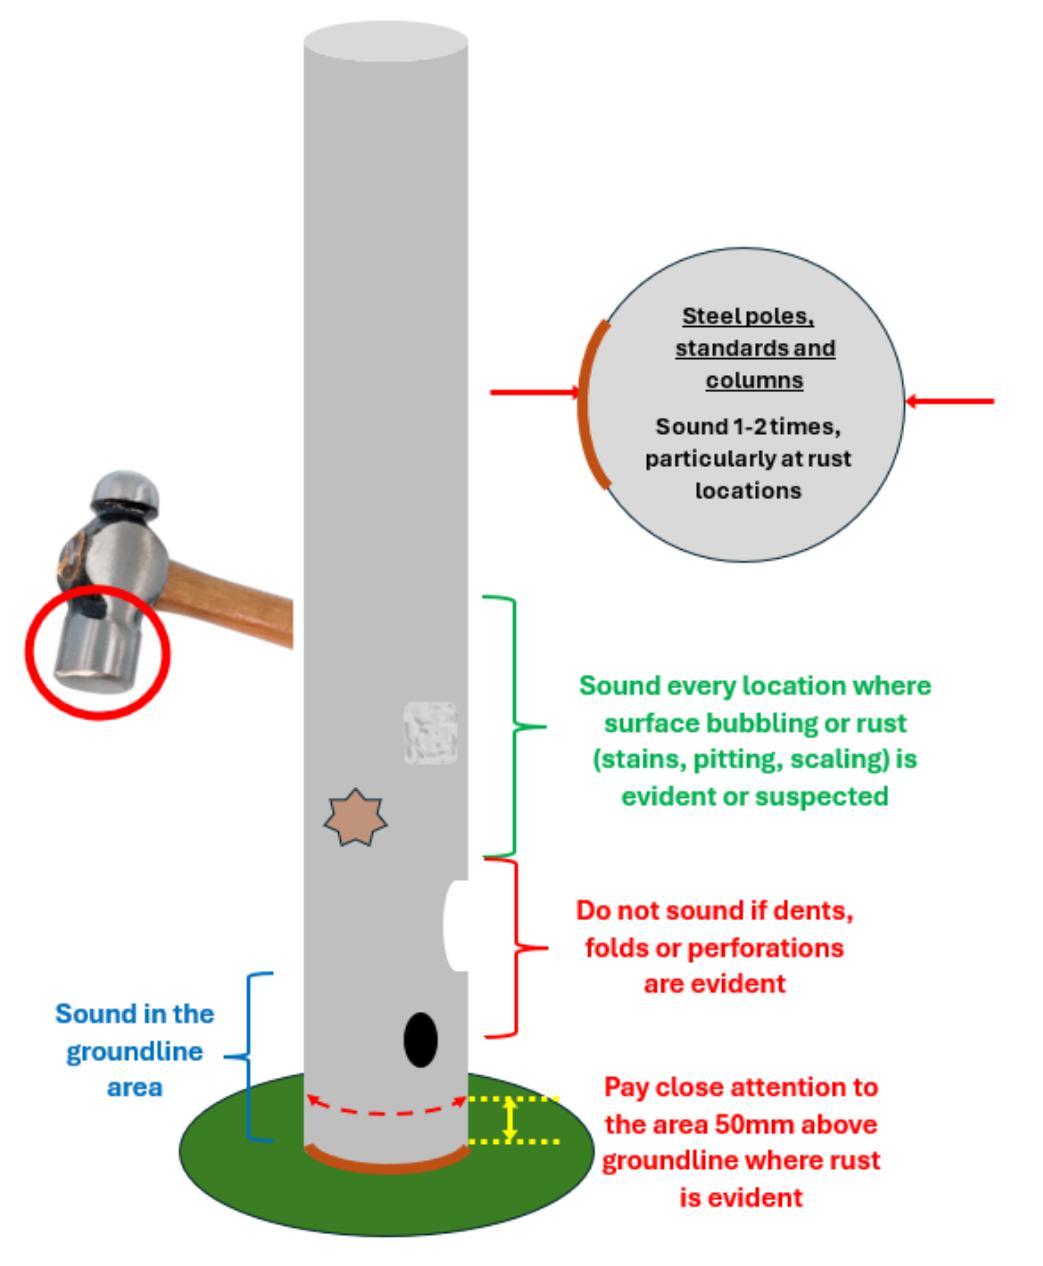
Figure 21 – Sounding Steel Poles, Standards and Columns Above Groundline

- 1 or 2 soundings (strikes) around the area just above groundline, and
- additional sounding at each location where surface bubbling, rust stains or scaling / pitted rust has been identified or is suspected.

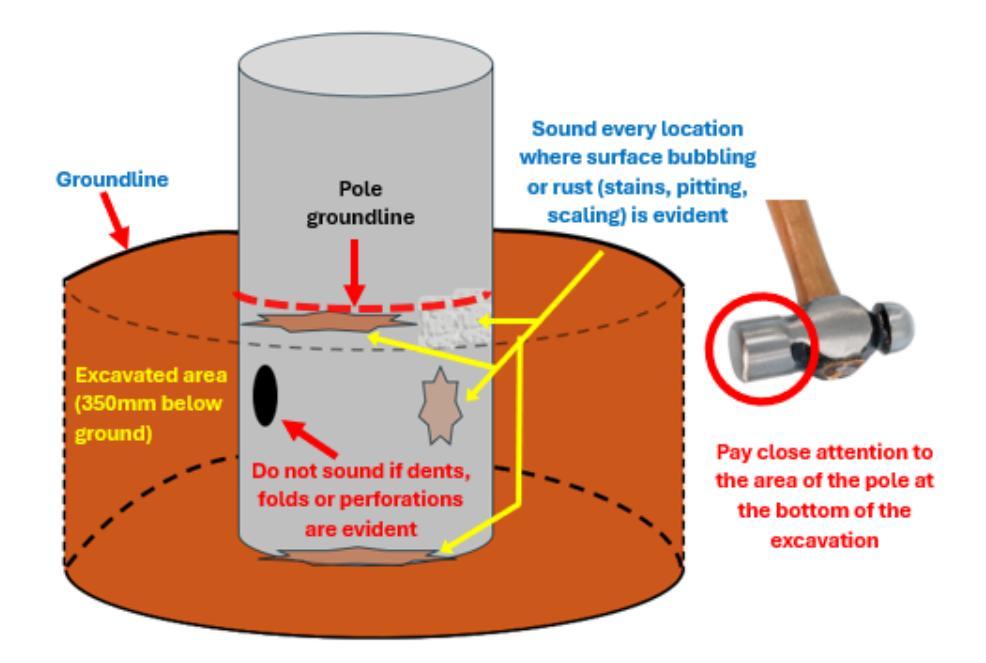
Sounding below ground shall be performed at each location where surface bubbling, rust stains or scaling / pitted rust has been identified or is suspected.

Figure 22 – Sounding Steel Poles, Standards and Columns Below Groundline Note: private poles shall not be excavated beyond a depth of 200mm.

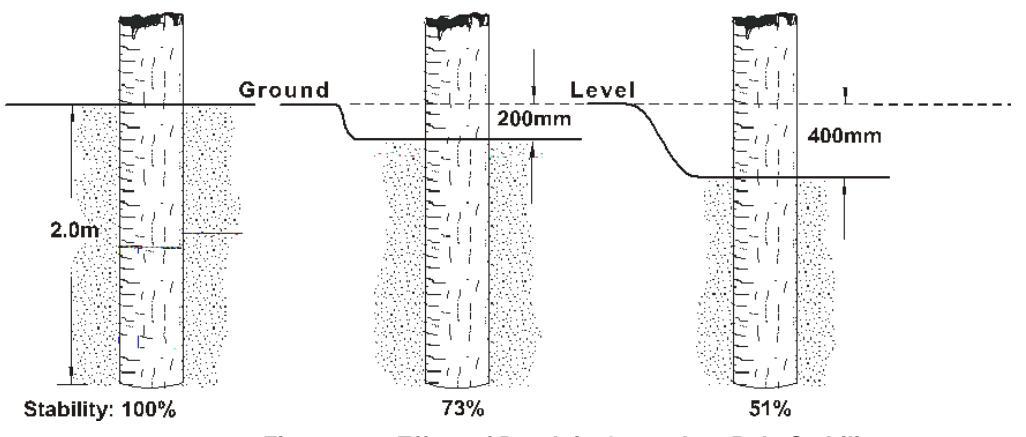
Figure 23 – Effect of Depth in Ground on Pole Stability

When poles are installed, they are 'sunk' to a depth sufficient to provide suitable stability against the effects of wind and pole-top loading due to overhead mains or other apparatus (refer to NS128 for the correct pole sinking depths). The stability of a pole can be severely affected by reductions in its depth in the ground as shown in Figure 23.

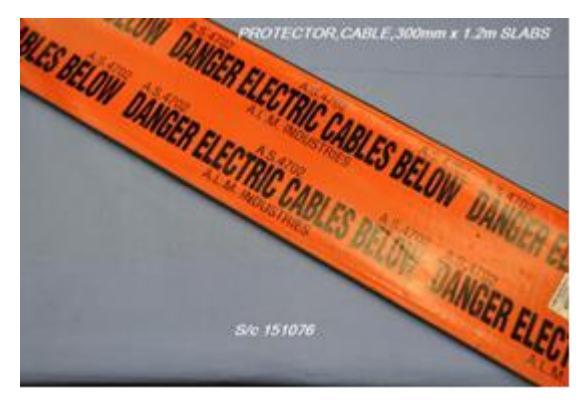
Figure 24 – Cable Protection Covers

Once a cable protection cover has been removed, further excavation near the cable/s shall not be completed with shovels or spades that require the use of two hands or other soil breaking implements. Only one-handed tools shall be used to remove the loose soil around the cables.

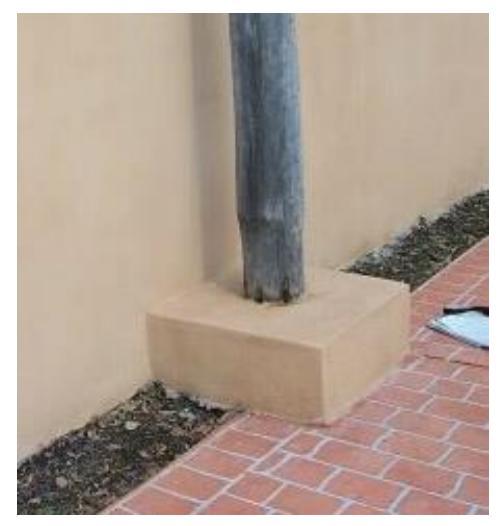
Figure 25 – Inaccessible Pole

Direct buried poles must be accessible for below ground inspection. Where they are found in locations where they cannot be correctly inspected (an example is shown in Figure 25), either the obstruction shall be removed to facilitate inspection, or the pole relocated.

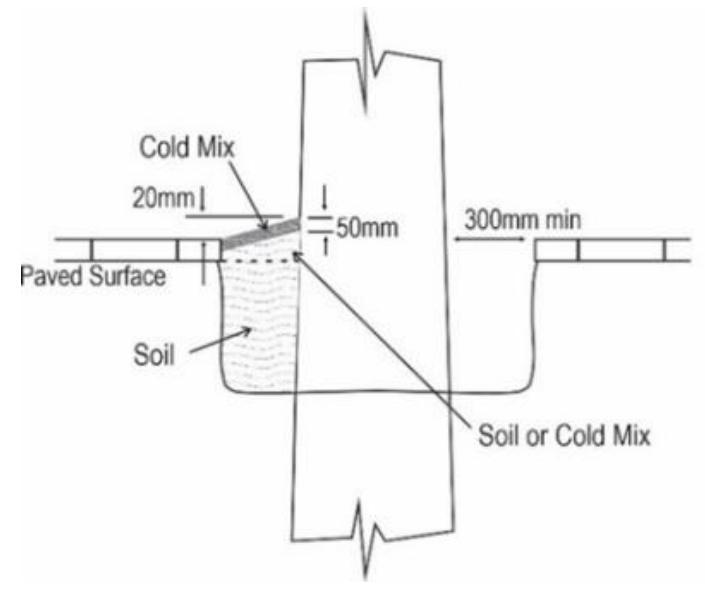
Figure 26 – Cold Mix Installation

The inspection area around the pole shall be reinstated with 50mm thick cold bituminous pre-mix material (refer to Figure 26) or, in the case of paving tiles which have been cut to fit neatly around the pole, these tiles are to be reused and left in an as found condition.

If using cold bituminous pre-mix material, the pre-mix material shall be placed such that there is a 20mm slope away from the pole towards the pavement. The pre-mix material is to finish slightly above the pavement level to allow for subsidence.

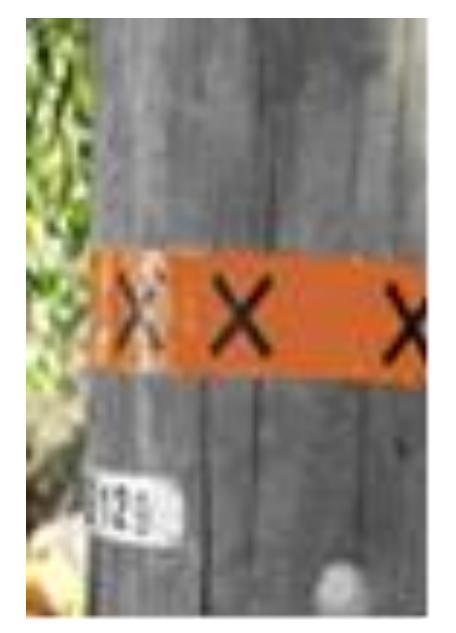
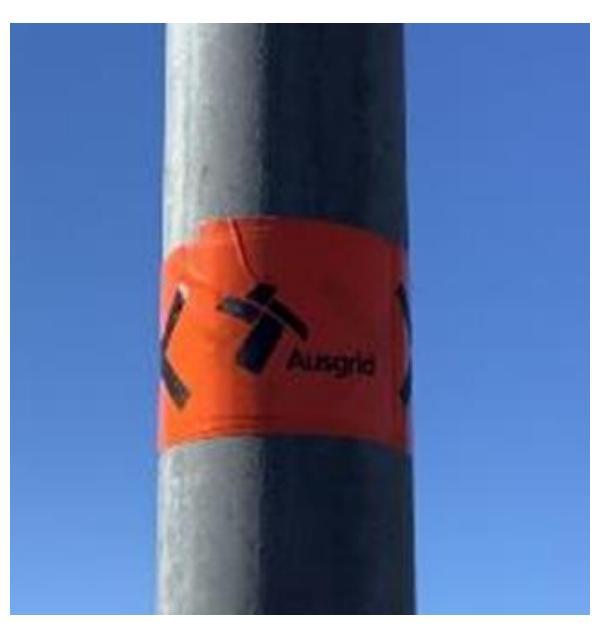
Figure 27 – Current methods for marking defective poles

Defective poles shall not be worked on unless they are supported during the work.

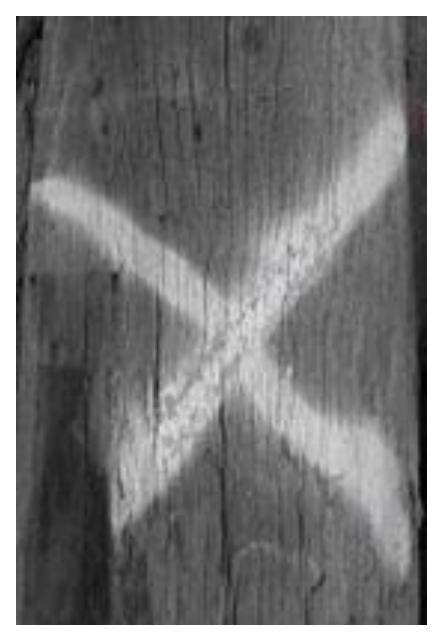
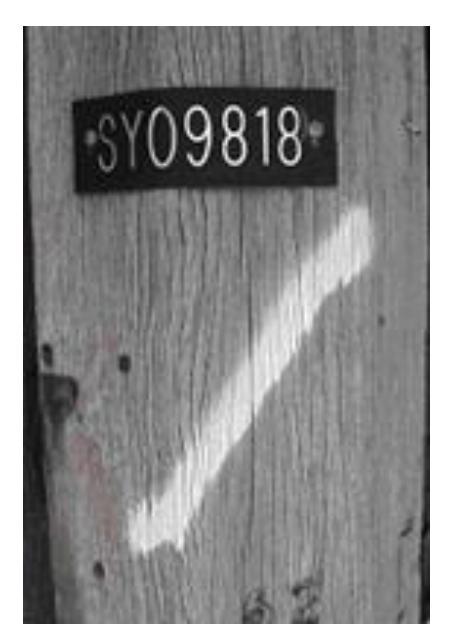
Figure 28 – Previous methods for marking defective poles

Defective poles have also been marked in accordance with Figure 28 in the past – the pole may also have an orange band with black symbols attached to the pole where an 'X' has been painted onto the pole.

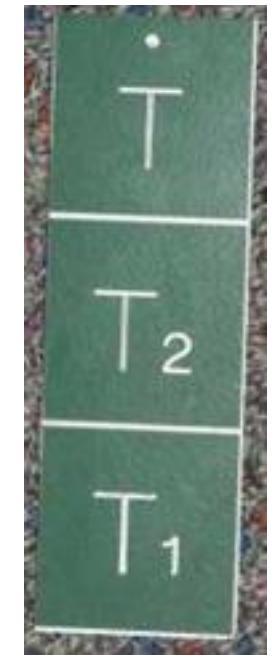
that active termites have been located in or near the pole.

Termite treatment has not commenced because there is no date stamped into the top 'T' segment of the tag.

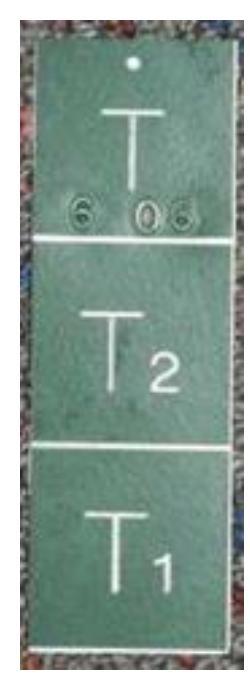
Step 2 The termite treatment has commenced but active termites are still present.

The month and year of the treatment have been stamped into the top 'T' segment of the tag.

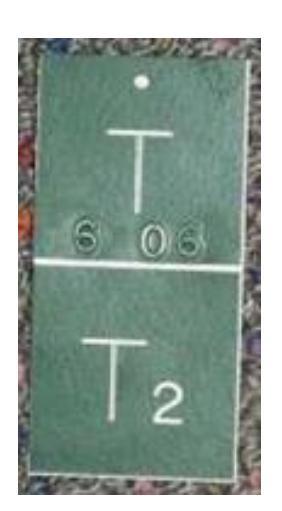
<u>Step 3</u> The first followup inspection has been

completed.

The bottom 'T1" segment of the tag is removed to show that there are no active termites.
